November 23, 2020

Re: Garey Residence Arborist Report

The Watershed Company Reference Number: 190405

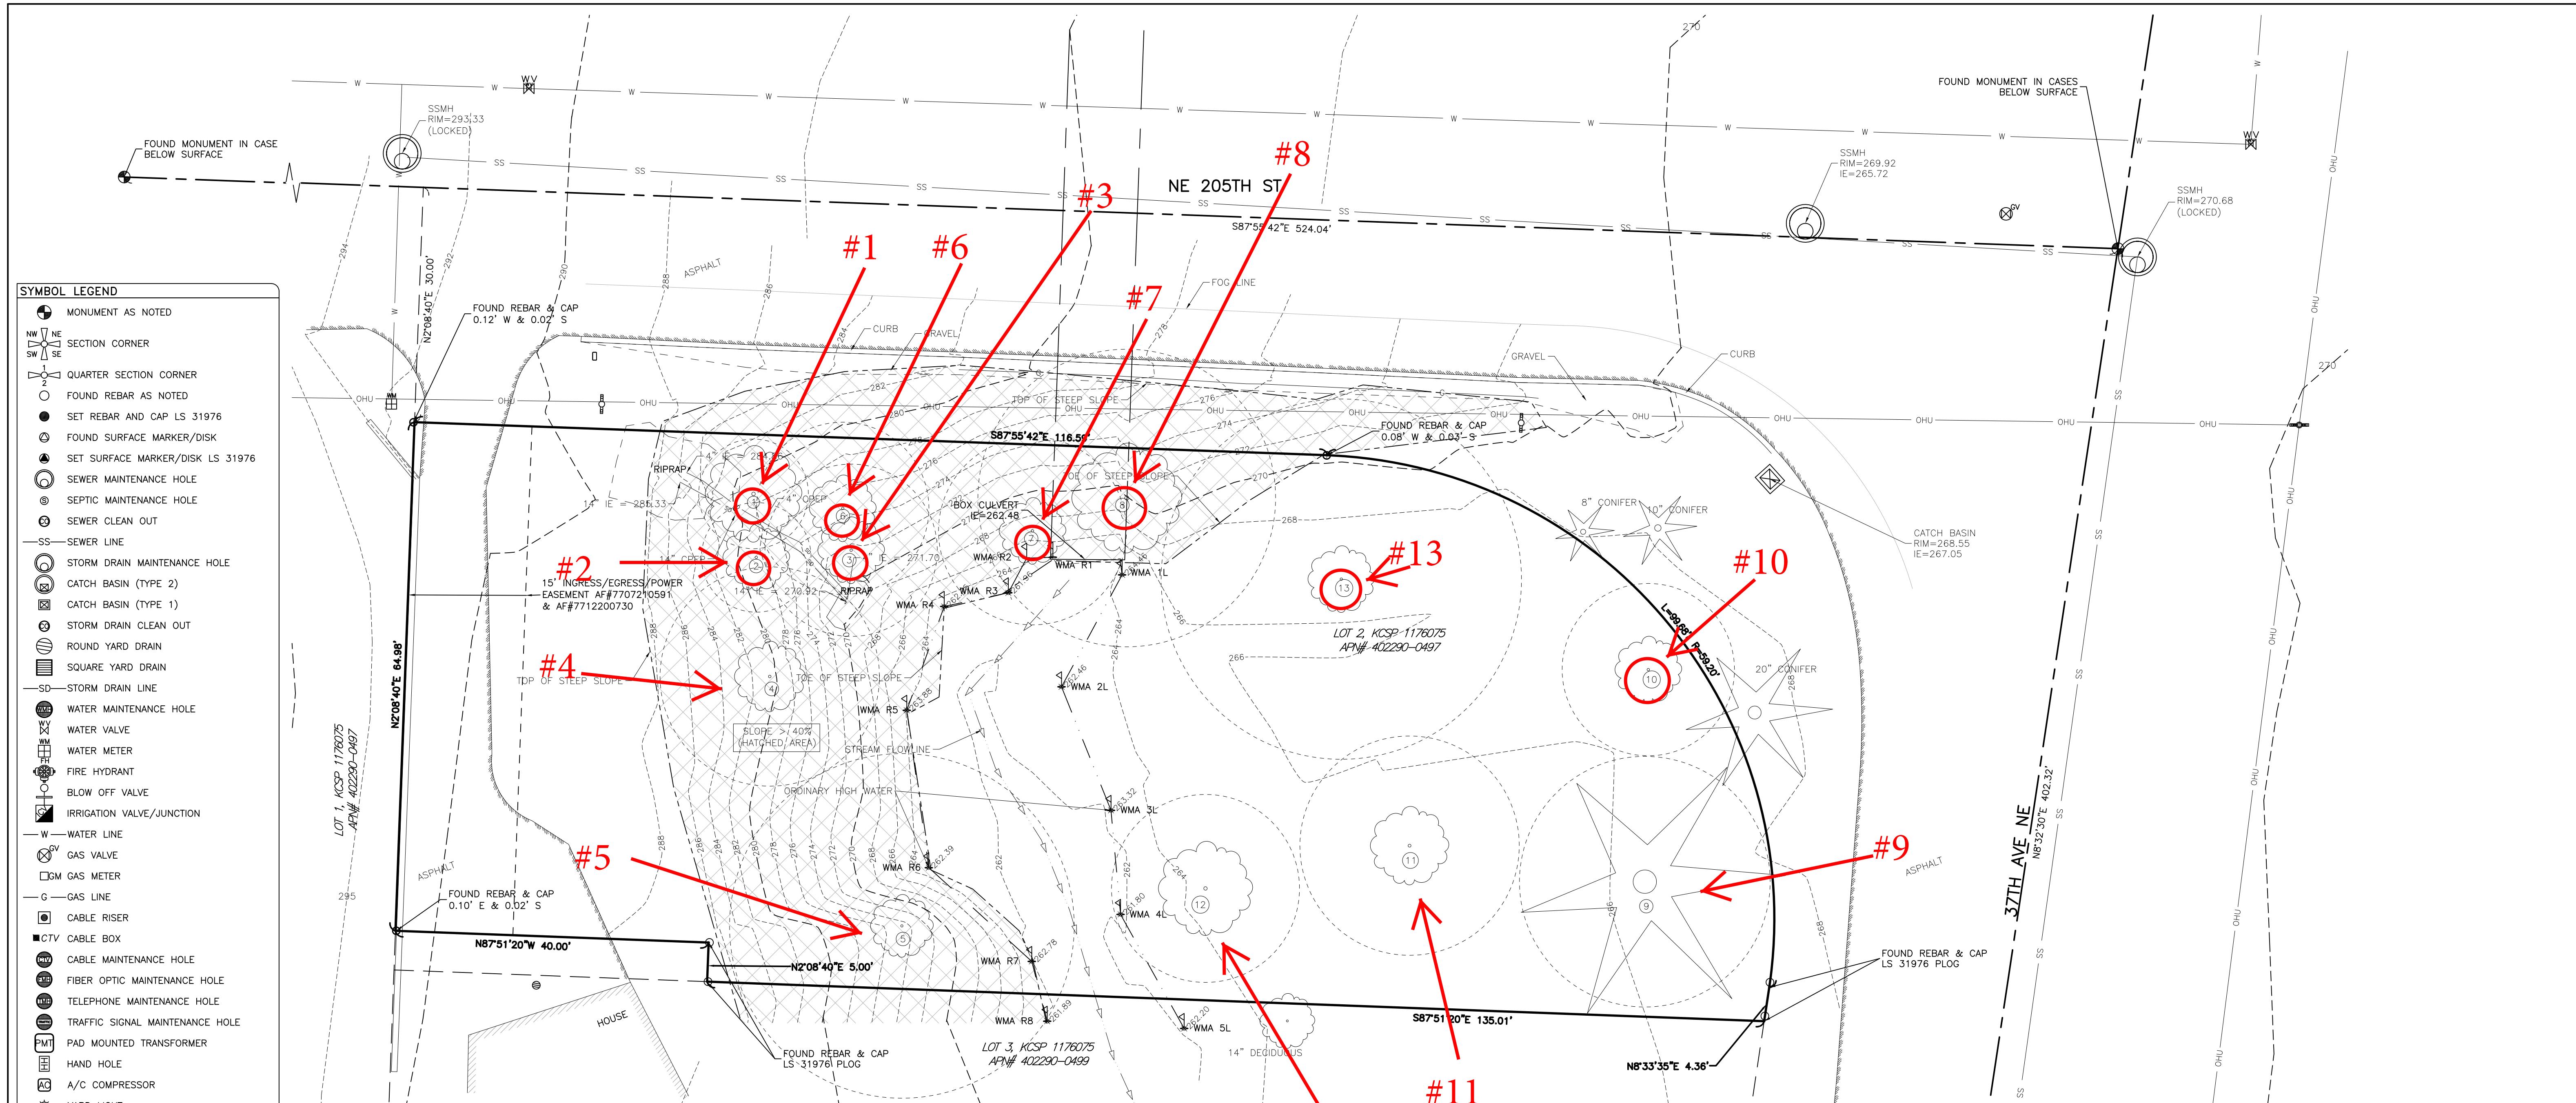
TAG #	TREE NAME	DN / DEC	COMB. DBH (in)	HEIGHT (FT)	RADIUS (FT)	CONDITION	SIGNIFICANT (Y/N)	LANDMARK (Y/N)	NOTES	
									STEMS	DBH (in)
1	Alnus rubra (Red alder)	D 1	12.3	35	7	Fair	Y	N	Located on steep slope.	
2	Alnus rubra (Red alder)	D 1	8.6	40	7	Fair	Y	N	Located on steep slope.	
3	Alnus rubra (Red alder)	D 1	8.5	40	11	Fair	Y	N	Located on steep slope.	
4	Populus trichocarpa (Black cottonwood)	D 1	18.0	45	14	Dead	N	N		
5	Alnus rubra (Red alder)	D 1	19.0	45	22	Poor	Y	N	Has an uncorrected lean to the East over the stream. Growing in sandy soil which is showing some signs of uplift.	
6	Alnus rubra (Red alder)	D 1	8.6	25	11	Fair	Y	N		
7	Alnus rubra (Red alder)	D 1	8.5	25	12	Fair	Y	N		
8	Alnus rubra (Red alder)	D 1	14.0	25	19	Poor	Y	N	Branches intertwined with overhead utility lines.	
9	Thuja plicata (Western red cedar)	E 1	36.3	100	16	Good	Y	Y	Co-dominant stems at 7 feet.	
10	Prunus sp. (Cherry species)	D 1	9.0	60	11	Poor	Y	N	Ivy growing up stem.

11	Populus trichocarpa (Black cottonwood)	D 1	20.0	50	14	Severe	Y	N	Fallen over but still sprouting new growth. Root plate still intact and buried.	
12	Populus trichocarpa (Black cottonwood)	D 1	36.0	30	12	Dead	N	N		
13	Alnus rubra (Red alder)	D 1	8.5	55	23	Fair	Y	N	Ivy growing up stem.
