Re: Arborist Review Tree Permit #2015-ARP-0012, Review and Recommendations
Site: Miles property, 3832 NE 155th St., Lake Forest Park, WA 98155

**ATTACHMENT: 2013 AERIAL SITE PHOTO
3832 NE 155th St.
Lake Forest Park, WA**

Attachment: Table of Trees
 Miles property
 3832 NE 155th St.
 Lake Forest Park, WA

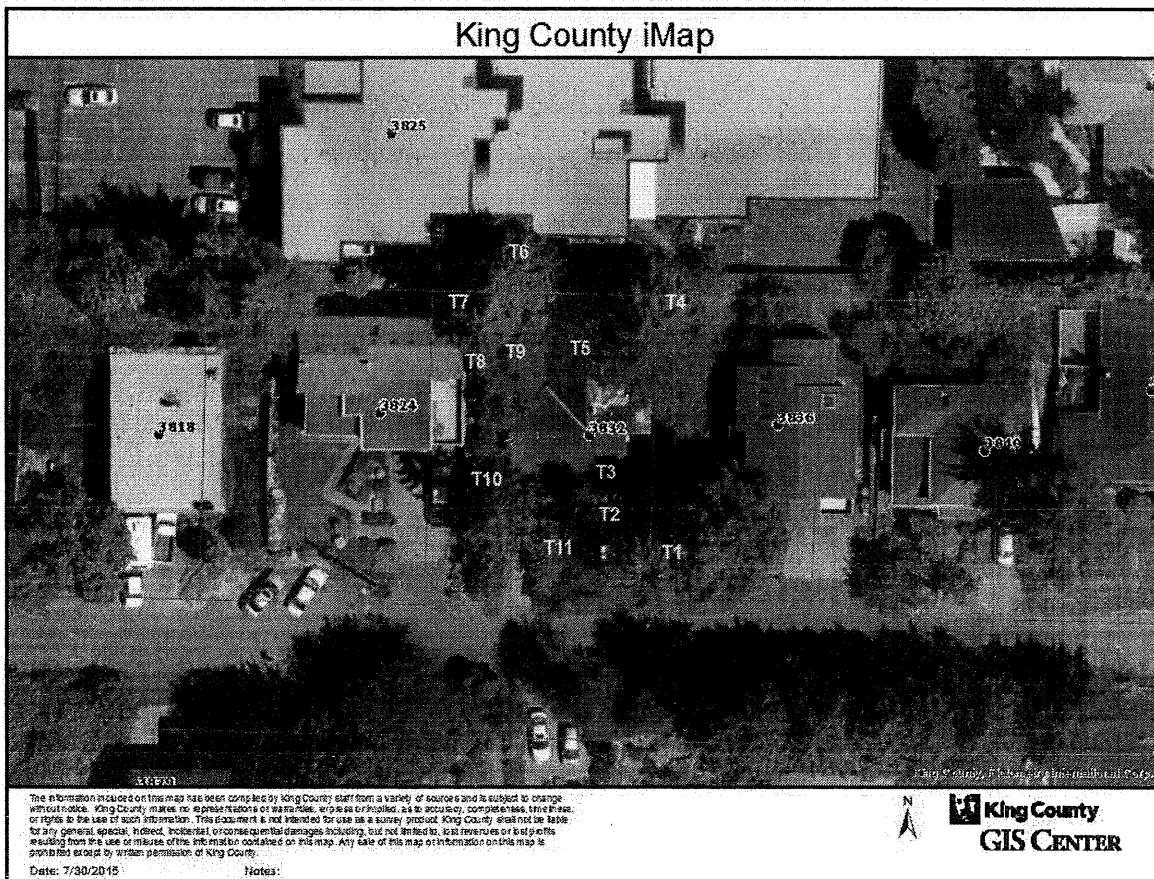
Trees numbered 2, 3, 9 and 11 are recommended for removal. They cannot be adequately protected from the proposed demolition activities or they are in poor health and condition and unworthy of long term retention. Tree 1 is located in the right-of-way of the overhead electric power lines(OHP). It was topped in the past for line clearance and now has multiple top leaders, a structural tree defect which makes failure more likely. There are available mitigation options to reduce risk, such as crown thinning and cabling. The tree is expendable, in my opinion, considering its location and potential for future conflict with the OHP. The crown of Tree 10 has thinning and fading foliage and appears to be in decline. It is located at the edge of the compacted driveway and I suspected root damage or root disease is creating the stress to the tree. The tree is expendable, in my opinion.

Locations of inventoried trees.

<u>Trees recommended for removal:</u>	<u>Trees to retain:</u>
T1	T4
T2	T5
T3	T6
T9	T7
T10	T8
T11

Trees numbered 4- 8 have the potential to be retained. They are generally in good overall health and condition and are suitable to tolerate the demolish work or construction activities. Activities impacts can be minimized by following the recommended tree protection measures, see *Attachment: Tree Protection Measures*.
