Consulting Arborist Services

Reference: Tree Inventory Report/Response to City Comments  
Tree Risk Assessment

Date: October 11, 2023

Site Address: 3803 NE 155th St, Lake Forest Park

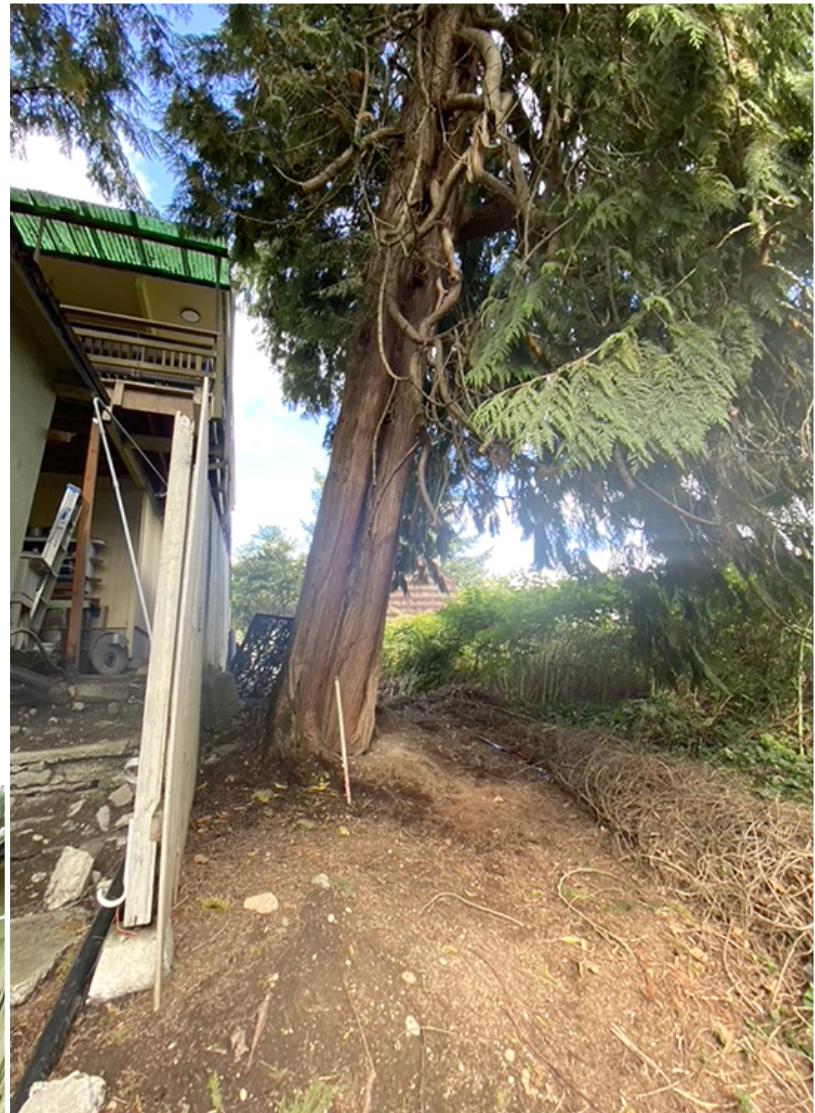
1. Past topping;
2. Limited soil volume;
3. Lean to southeast;
4. Visible decay in sapwood;
5. Compact soils.

Right: Looking north, below the tree. Lean southeast. Neighboring foundation wall on left may restrict root growth. Structure/building limits rain to roots.

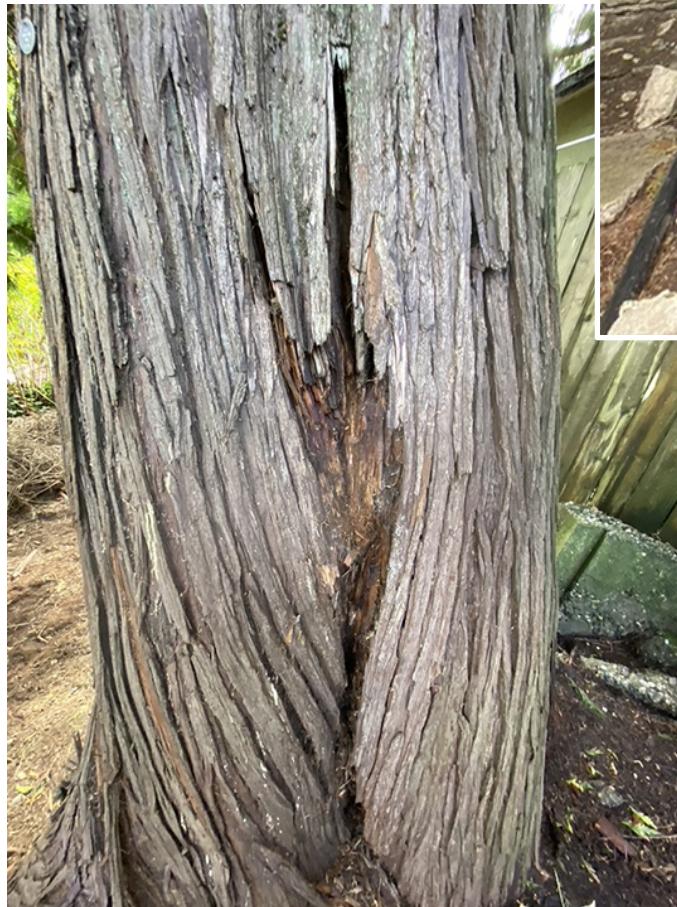
Left: Looking at the north side of the trunk. Clear indication of bark and sapwood rot in trunk. Sufficient sound wood exists surrounding visible decay. Tree is vulnerable to site disturbance.

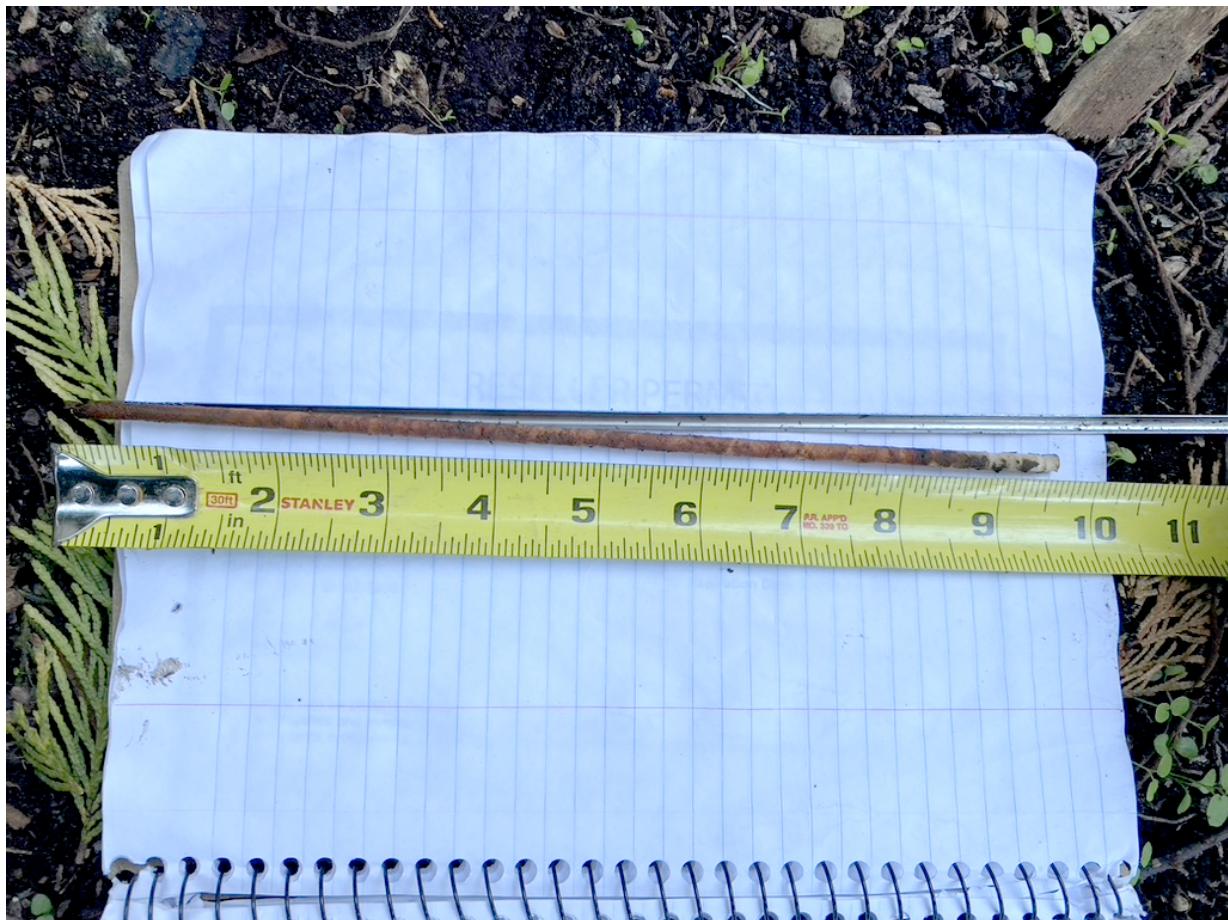
Core sampling reveals six (6) to eight (8) inches of sound wood, past the bark, before reaching what I suspect to be central heartwood decay. I relied on the core samples as well as resistance to the increment borer to measure decay.

Decay at 6"

Sound Wood – Incipient (early) Decay – 6"

Bark 1.5"

Core sample taken 90 degrees away from visible bark and sapwood decay, moving clockwise around tree. The first 1.5 inches indicate bark, followed by 6 inches of sound wood, with some signs of incipient decay (early stages). Heartwood decay is present at 6 inches past the bark. A second sample one foot toward the neighbor's house from point of visible bark decay shows similar results.

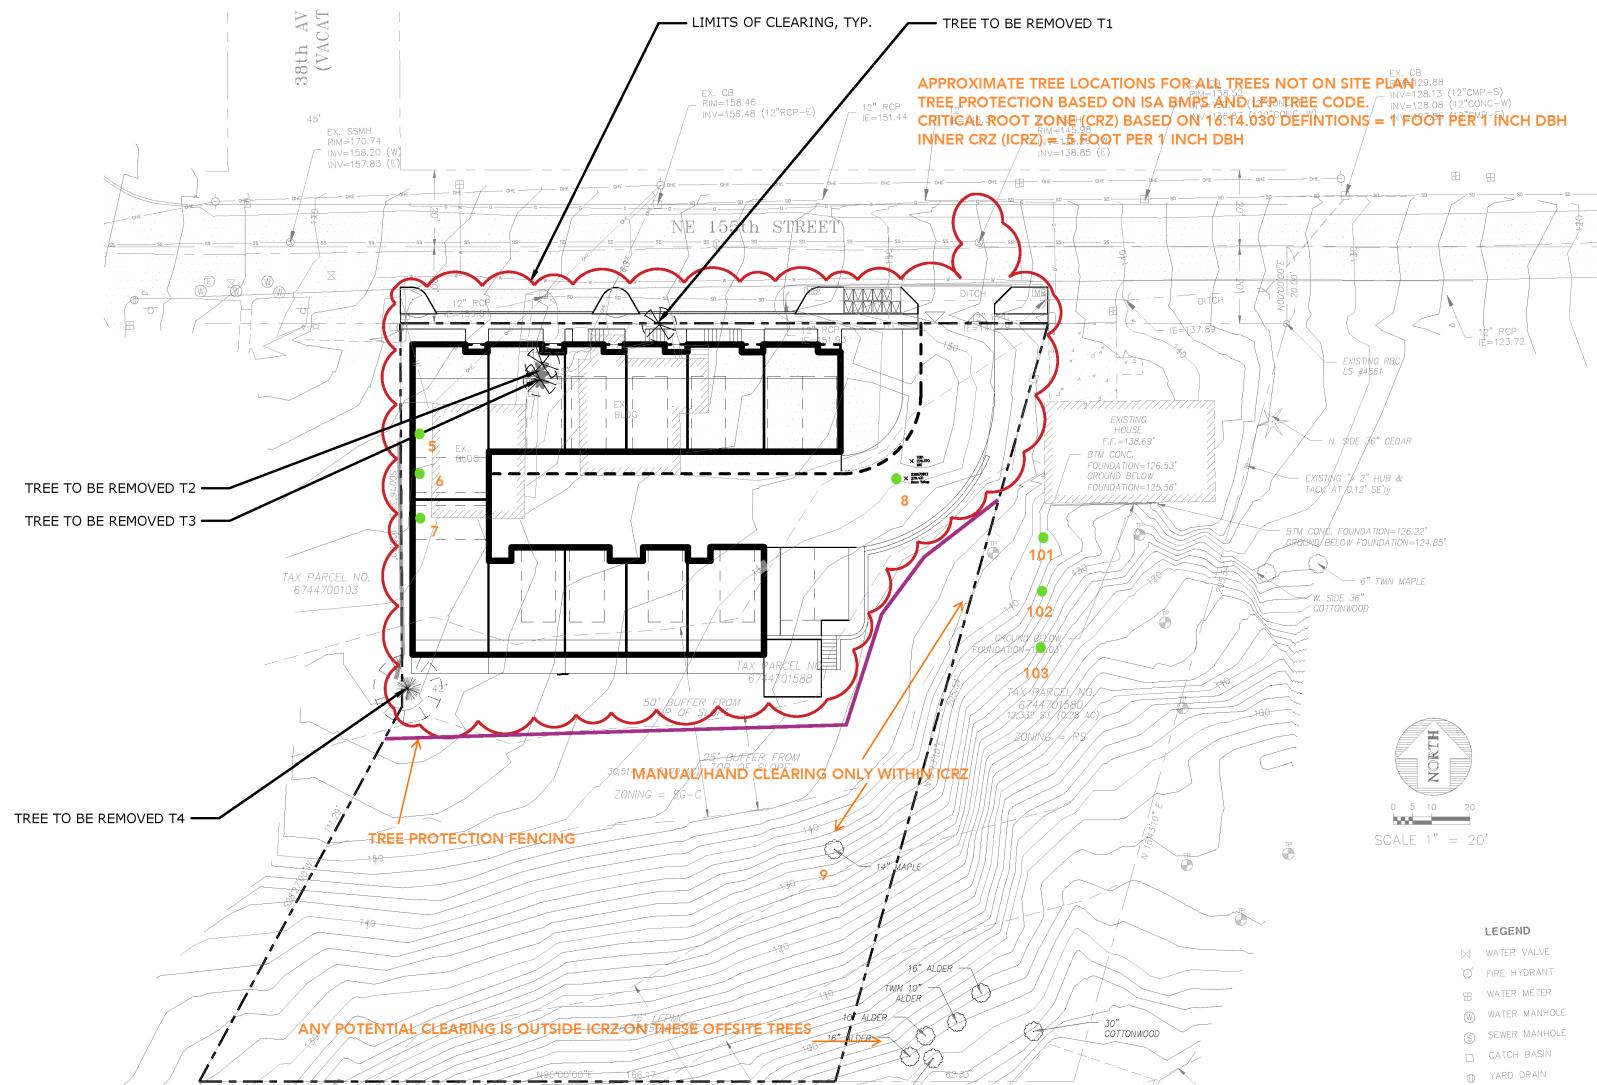
Attachment 4: Annotated Site Plan

I have provided a recommendation for tree protection fencing location to be placed along the limits of clearing as indicated on the annotated site plan. Any clearing activity which crosses inside the inner CRZ (one-half the CRZ) must be completed manually, using hand tools to minimize root disturbance on Tree #9, and offsite Trees #101, #102, and #103. Any ground disturbance by machinery within the tree protection areas of these trees must be monitored and documented by the project arborist.

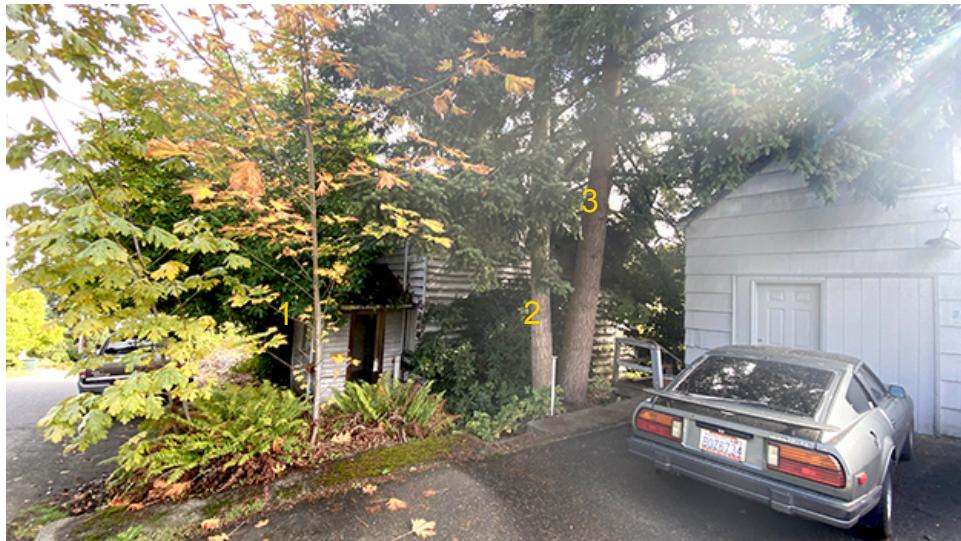
Left: Looking east from northwest property corner. Tree #1 is in background at left. Trees #2 and #3 are center, in between the two buildings.

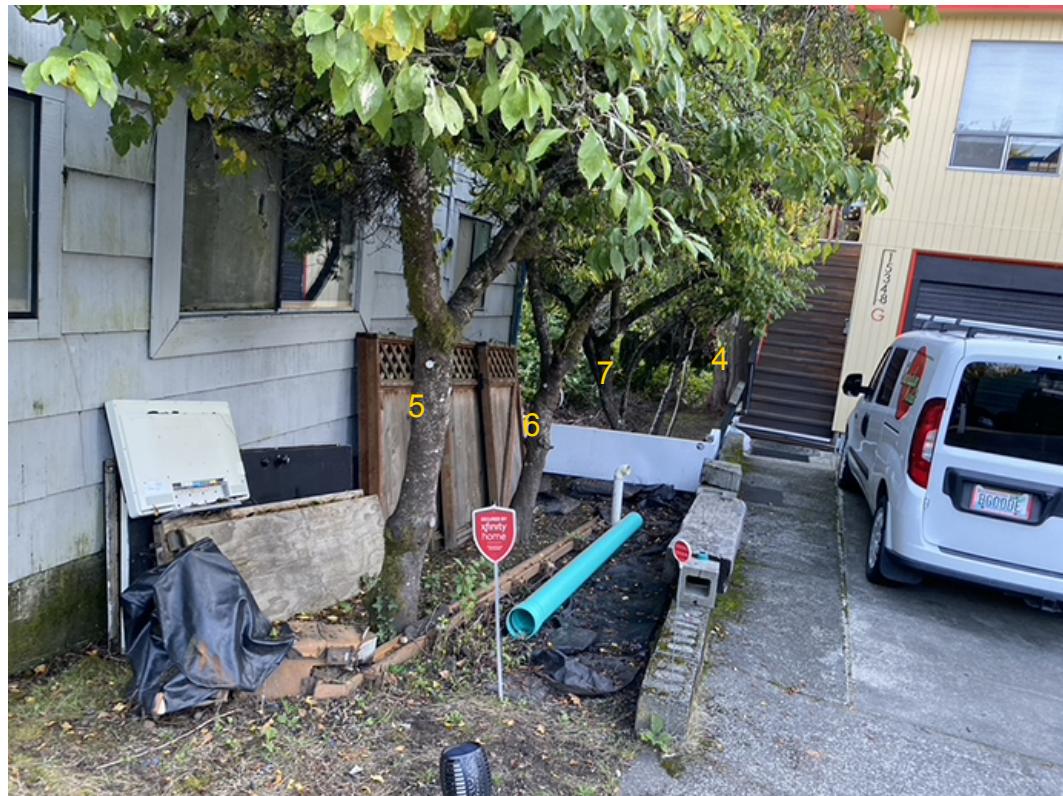
Below: Looking south along west side of building. A row of fruiting cherry trees, three (3) of which are significant.

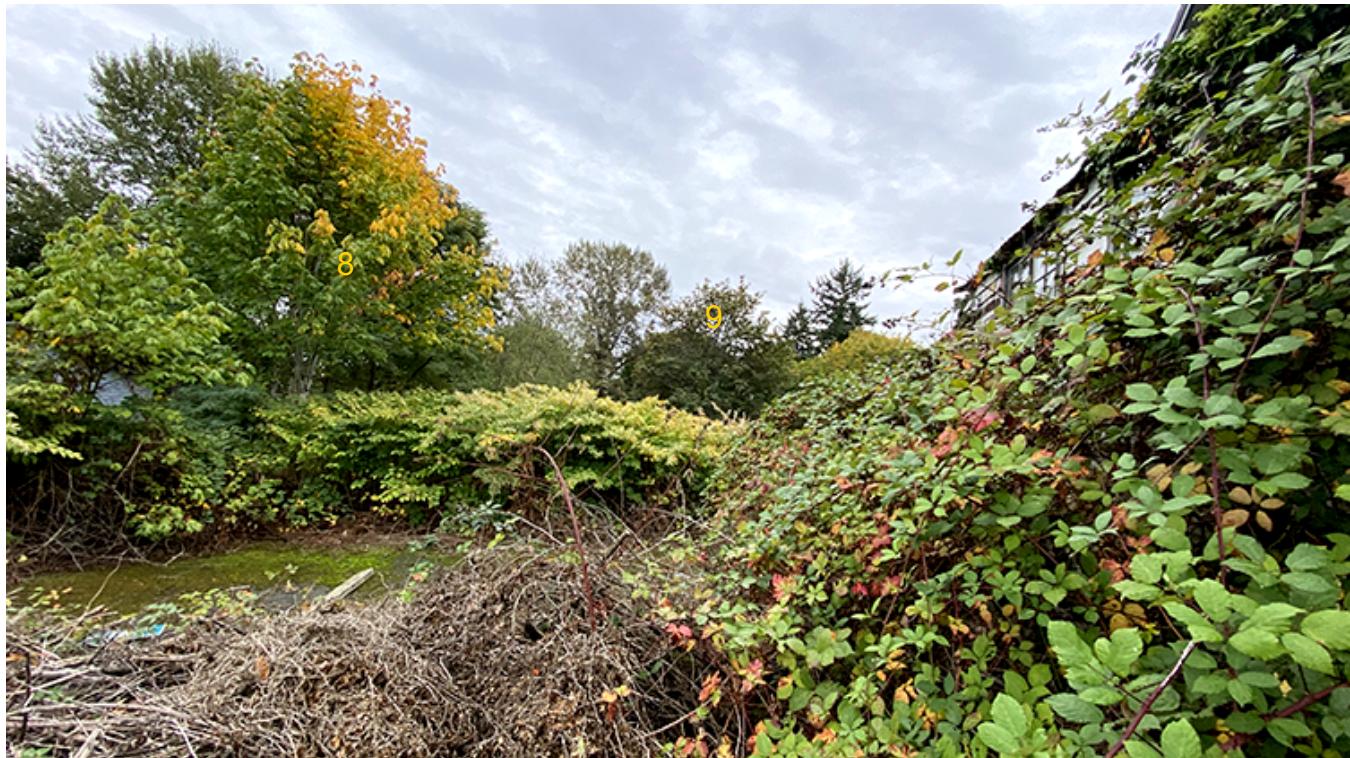
Looking south/southeast from NE 155th Street. Tree #8 is turning color on the left, Tree #9 is at center.

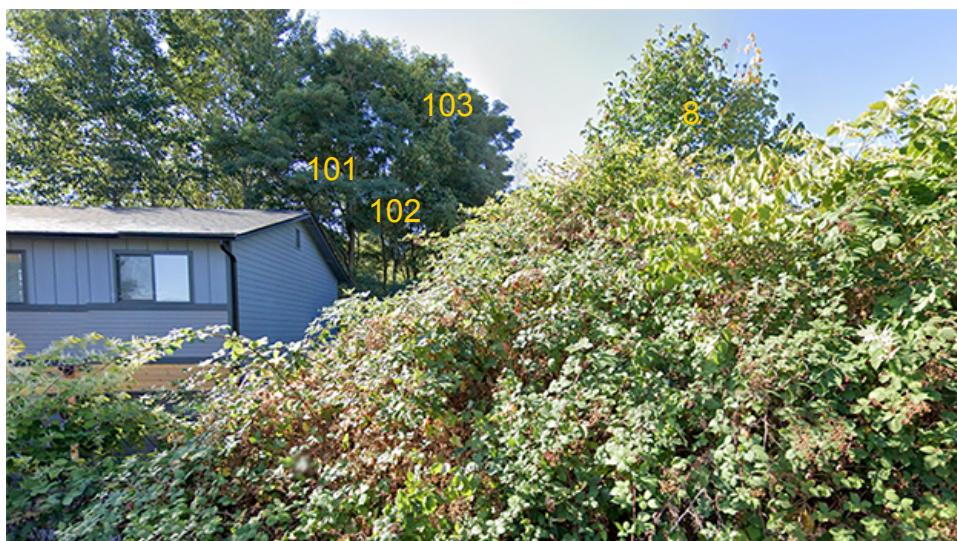
Offsite Trees #101, #102, and #103 can be seen in the photo below from Google street view, 2019.
