Critical Areas Report- Revised

GAREY REASONABLE USE DEVELOPMENT LAKE FOREST PARK

September 20, 2021

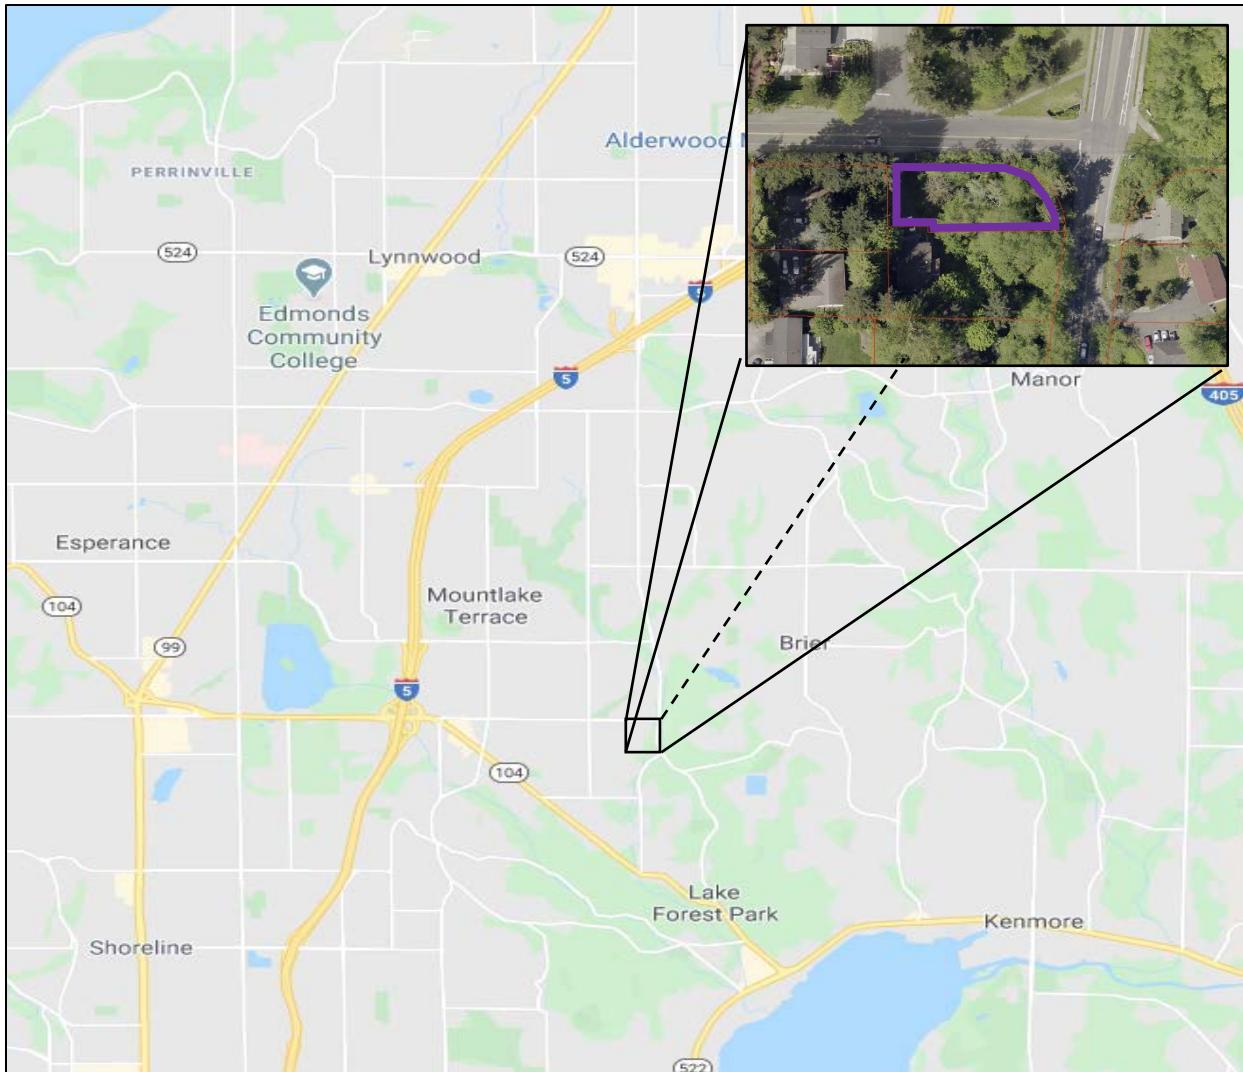
Figure 1. Vicinity and study area map, subject parcel in purple outline.

The subject parcel, #4022900497, has no assigned address and is on the southwest corner of NE 205TH Street and 37th Avenue NE within City of Lake Forest Park jurisdiction (Figure 1). It is at the north end of City limits, in the northwest $\frac{1}{4}$ Section 3, Township 26 North, Range 4 East of the Public Land Survey System.

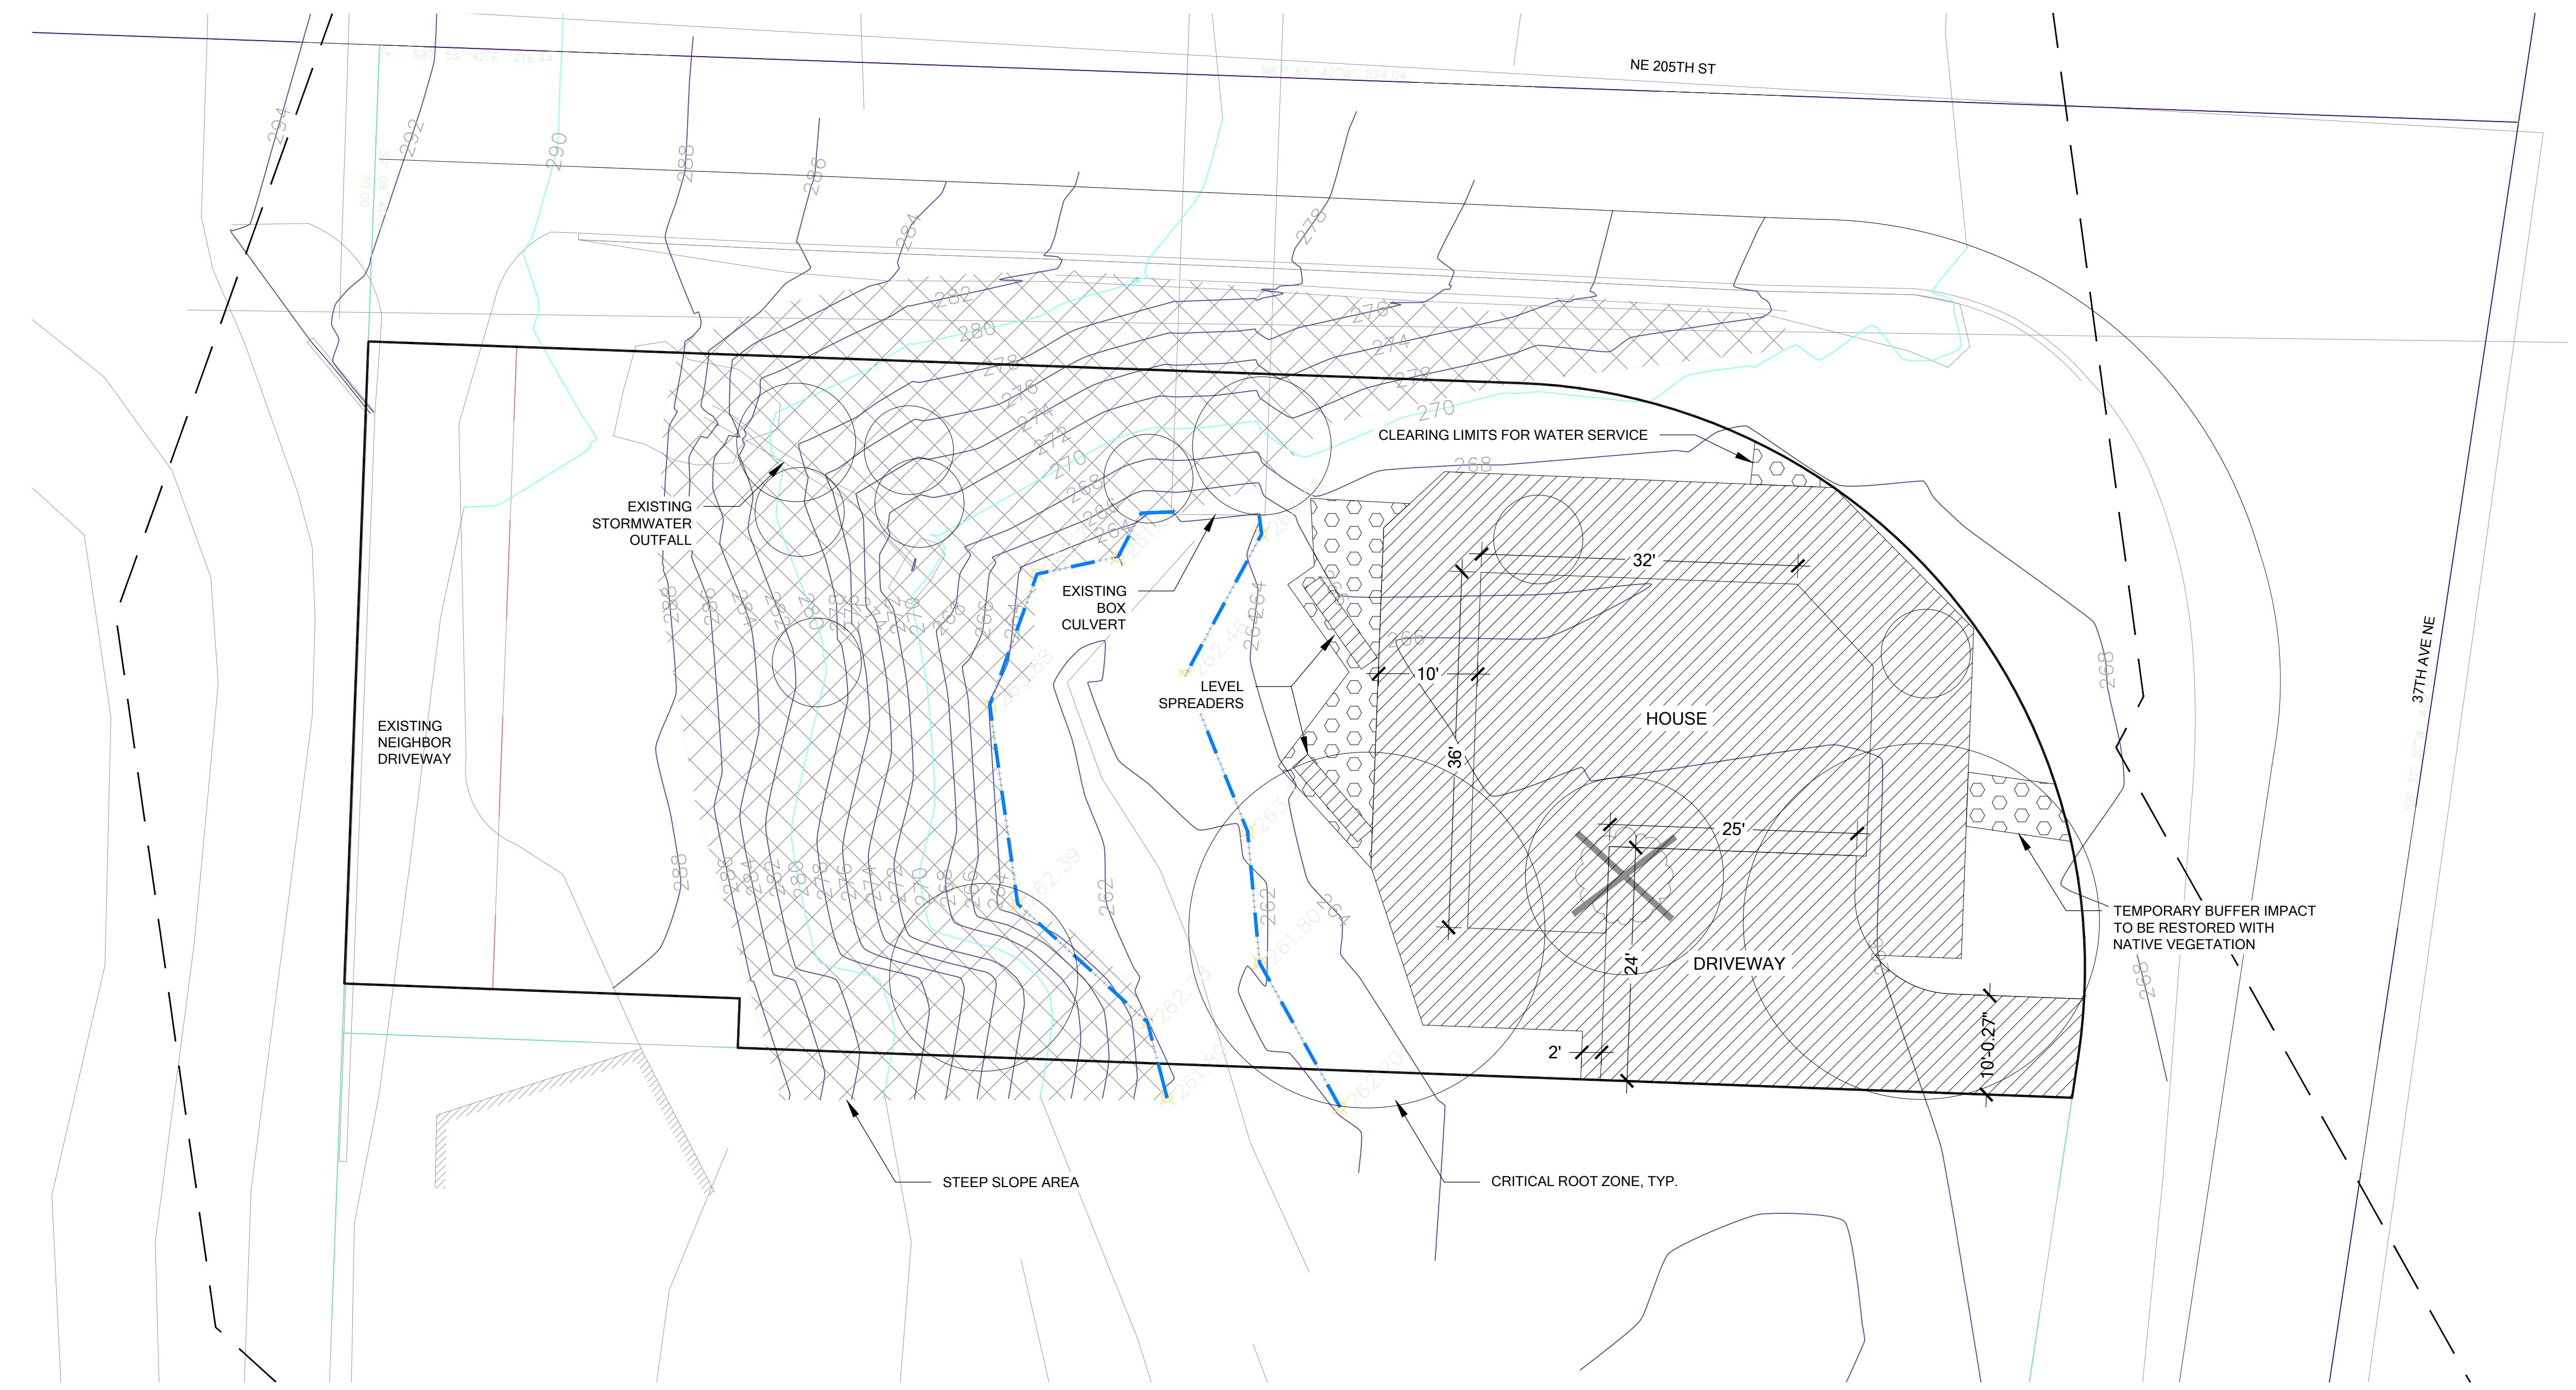
PROPOSED IMPACTS ASSESSMENT

SCALE 1" = 10'

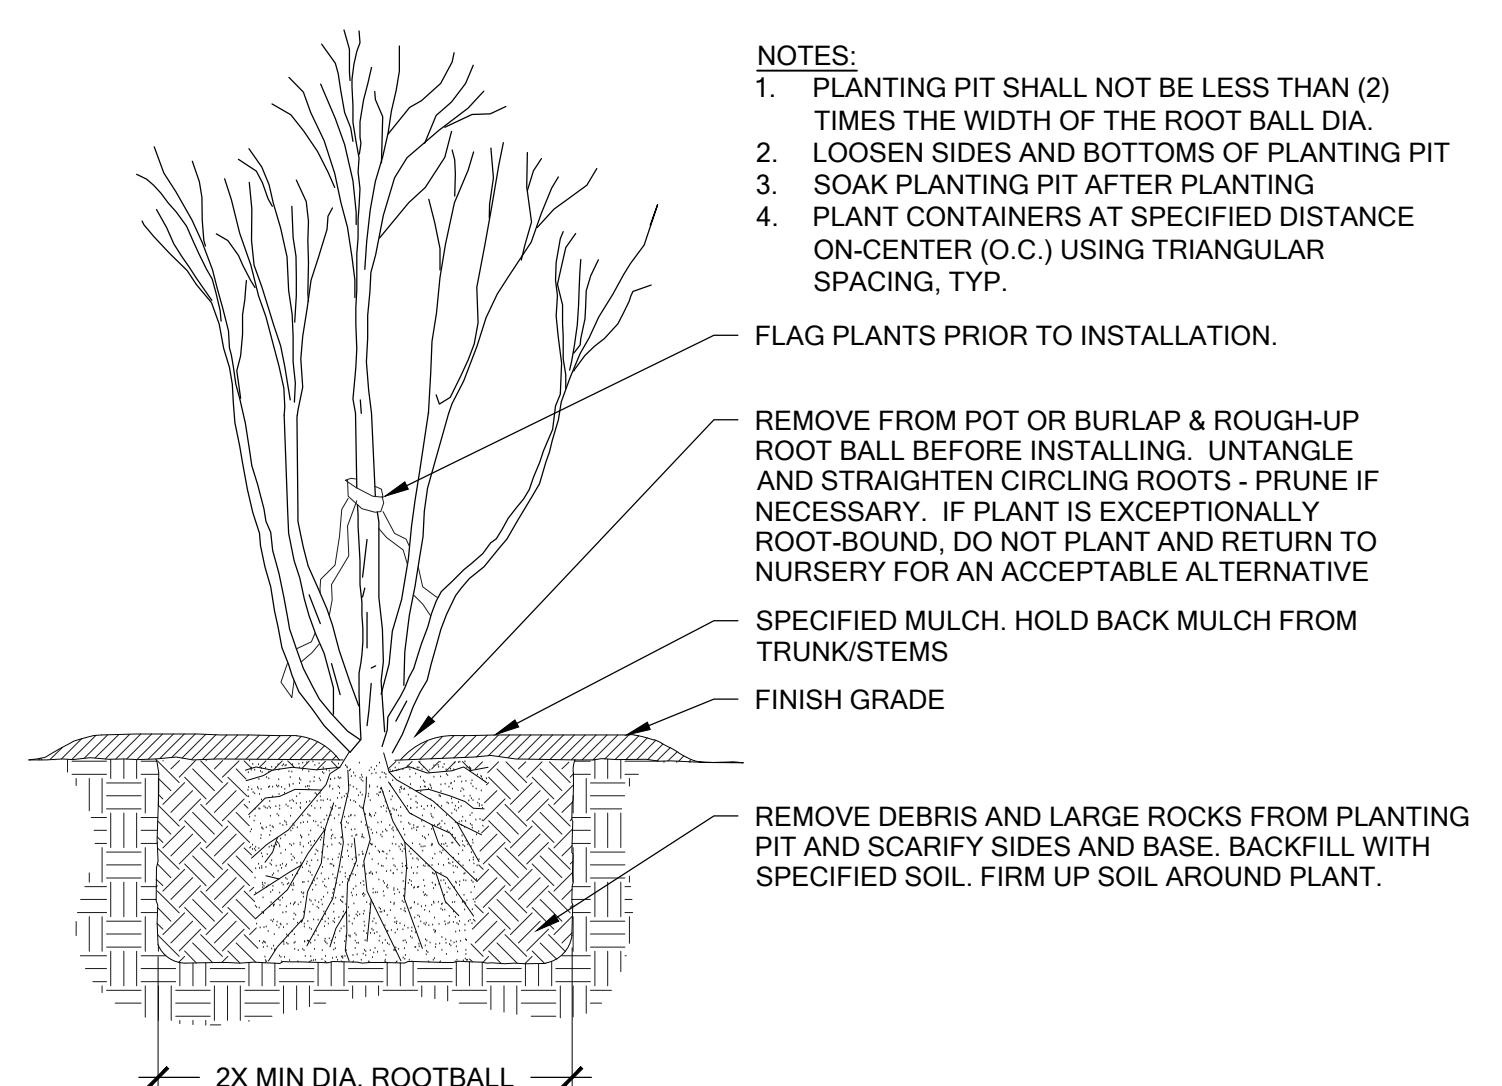
2 CONTAINER PLANTING

Scale: NTS

3. Prepare site soils per the site preparation plan (sheets W4 and W5).
4. Install native plants per planting details on sheet W4 and W5.
 - A. Native plant installation shall occur during the dormant season (October 15th through March 1st) in frost-free periods only.

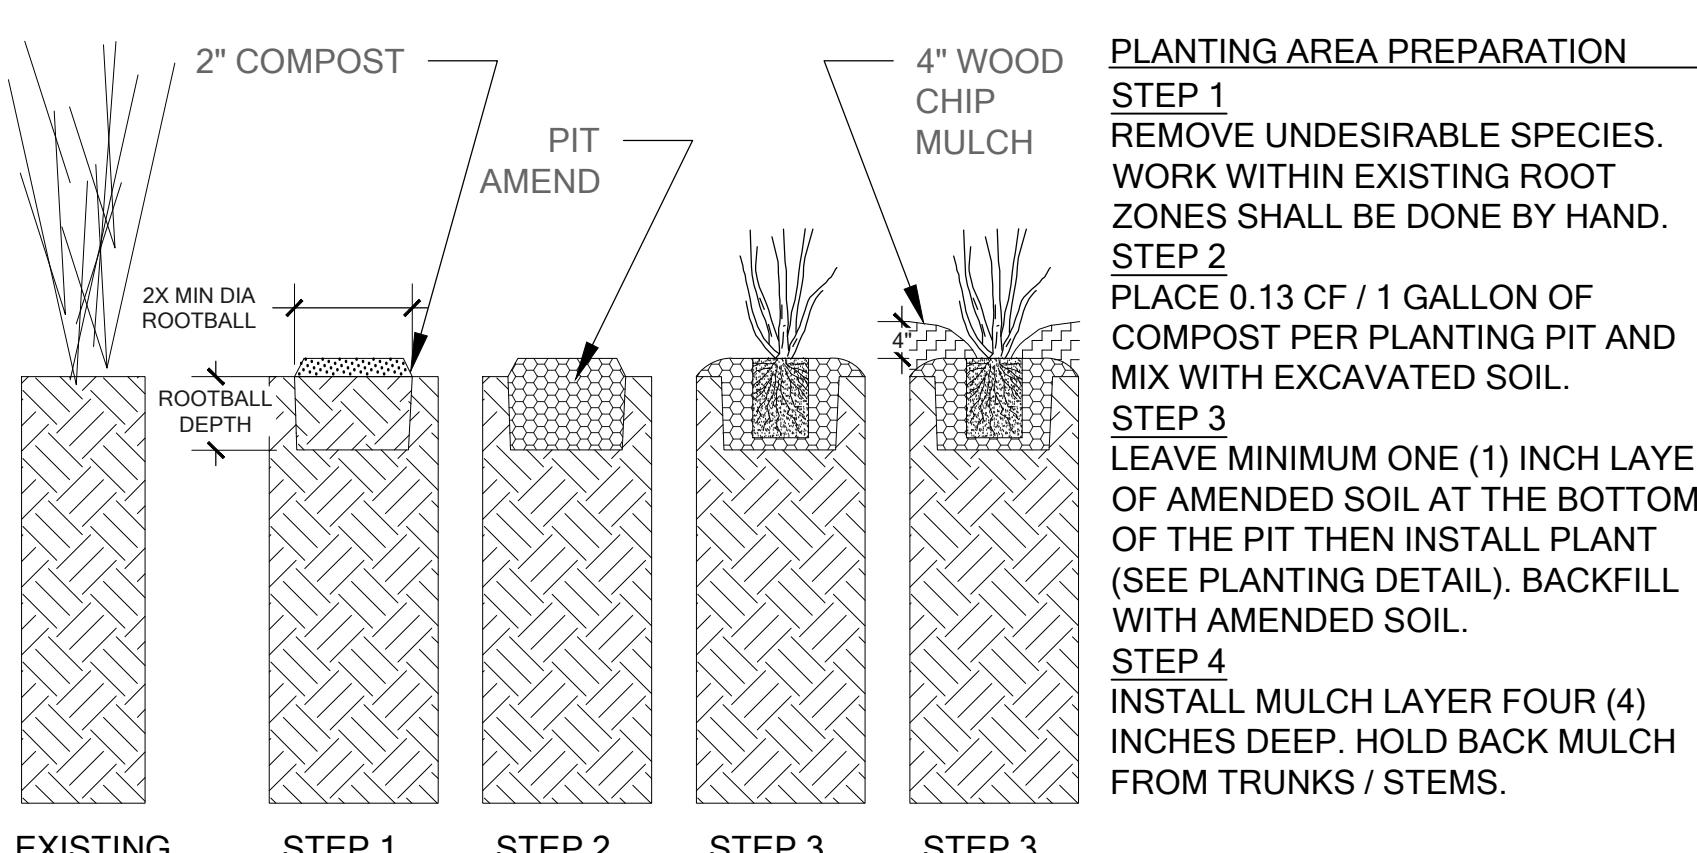
1 SITE PREPARATION

Scale: N

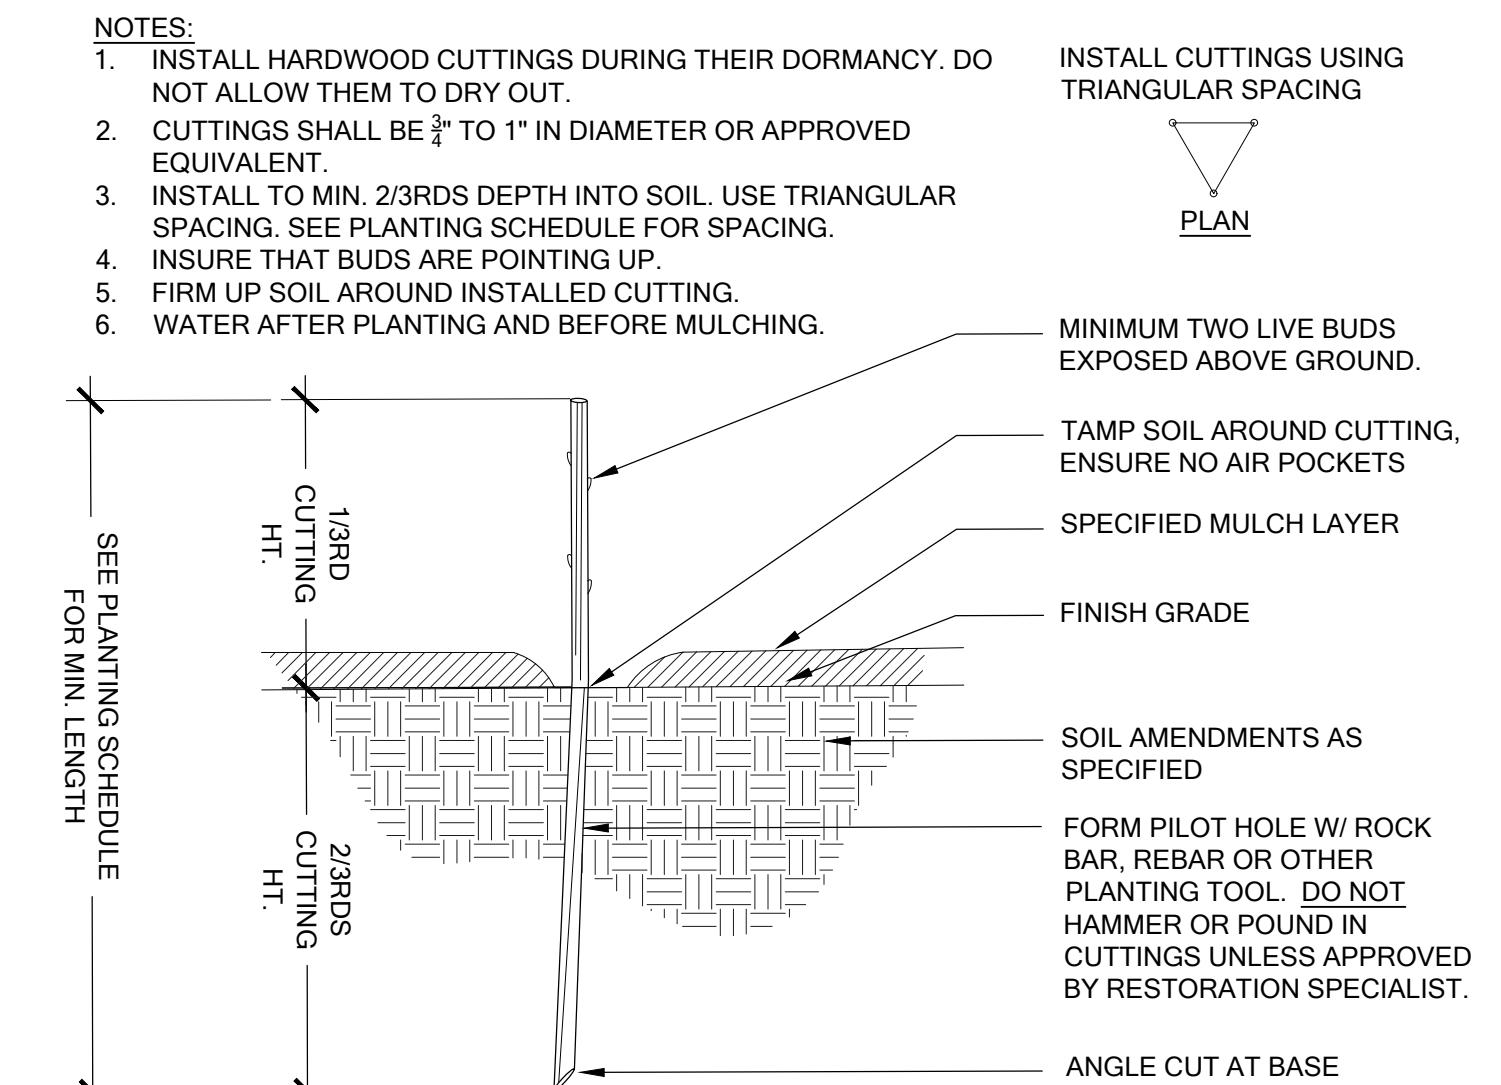
3 LIVE STAKE PLANTING

Scale: NTS

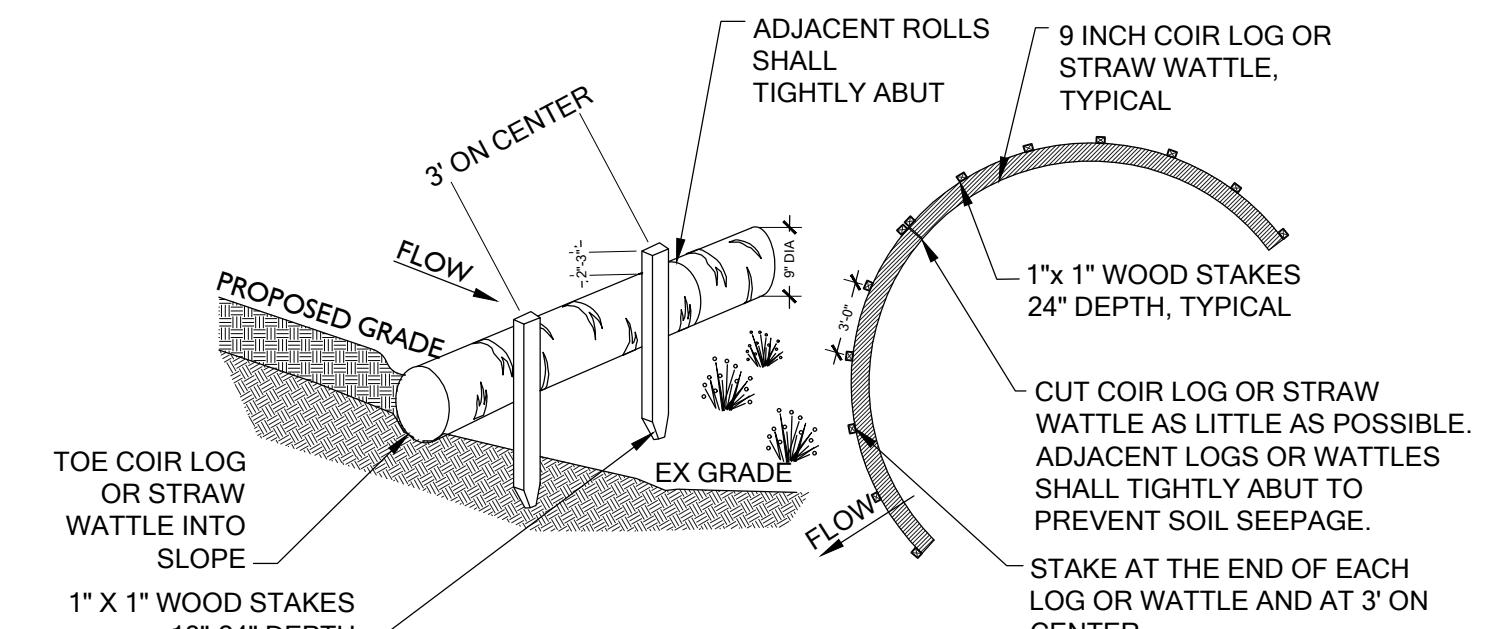
1 COIR WATTLE

3. STAKING: WOODEN STAKES ARE RECOMMENDED TO SECURE THE COIR LOG OR STRAW WATTLE. BE SURE TO USE A STAKE THAT IS LONG ENOUGH TO PROTRUDE SEVERAL INCHES ABOVE THE COIR LOG OR STRAW WATTLE: 18" IS A GOOD LENGTH FOR HARD, ROCKY SOIL; FOR SOFT LOAMY SOIL USE A 24" STAKE.

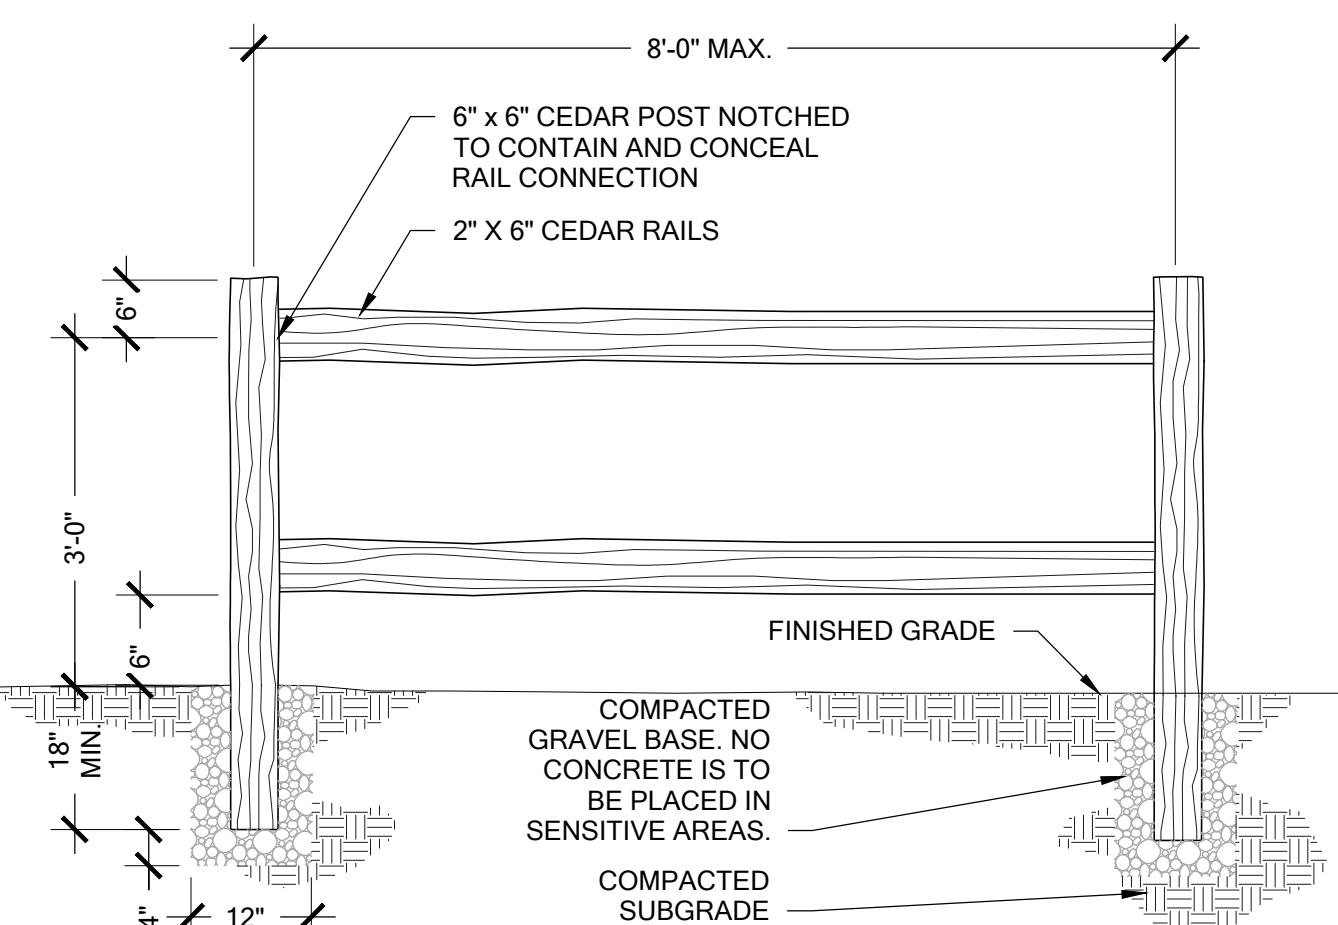
2 SPLIT RAIL FENCE

Scale: NTS

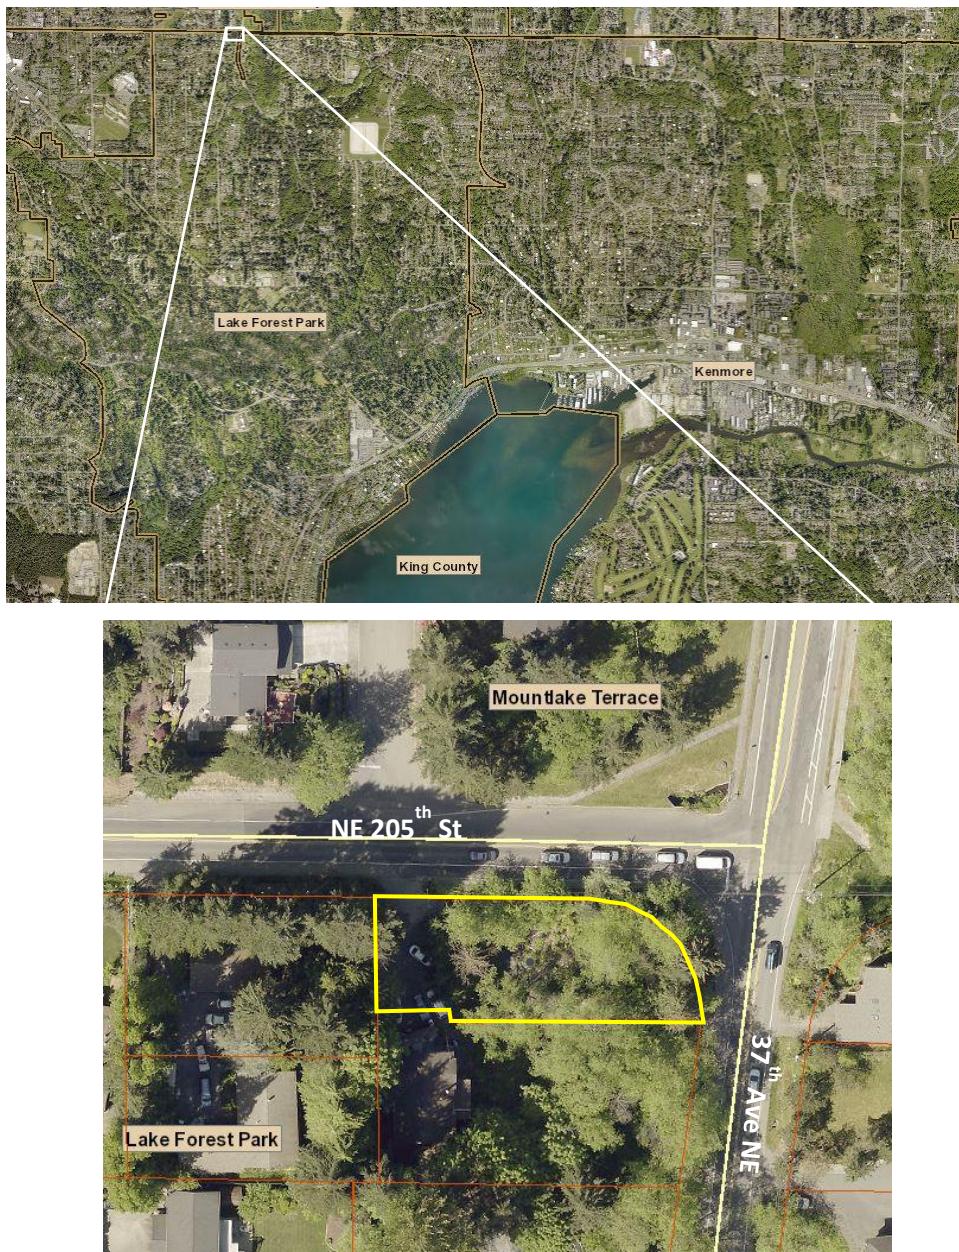
Figure 1. Defined extent of parcel outlined in yellow. Images courtesy of King County iMap.

The subject property is 11,369 square feet in size and is currently undeveloped with an identified stream and corresponding buffer. A moderate slope is located on the northern and western portion of the parcel, but it has not been identified as an Erosion Hazard on King County iMap. See *Stream Delineation Study* dated June 18, 2019 by The Watershed Company for more information on environmentally critical areas. The subject property is a corner lot with single-family parcels to the south and west, NE 205th St forms the northern border, and 37th Ave NE forms the eastern border. The site is currently zoned for residential use (RS 9600).

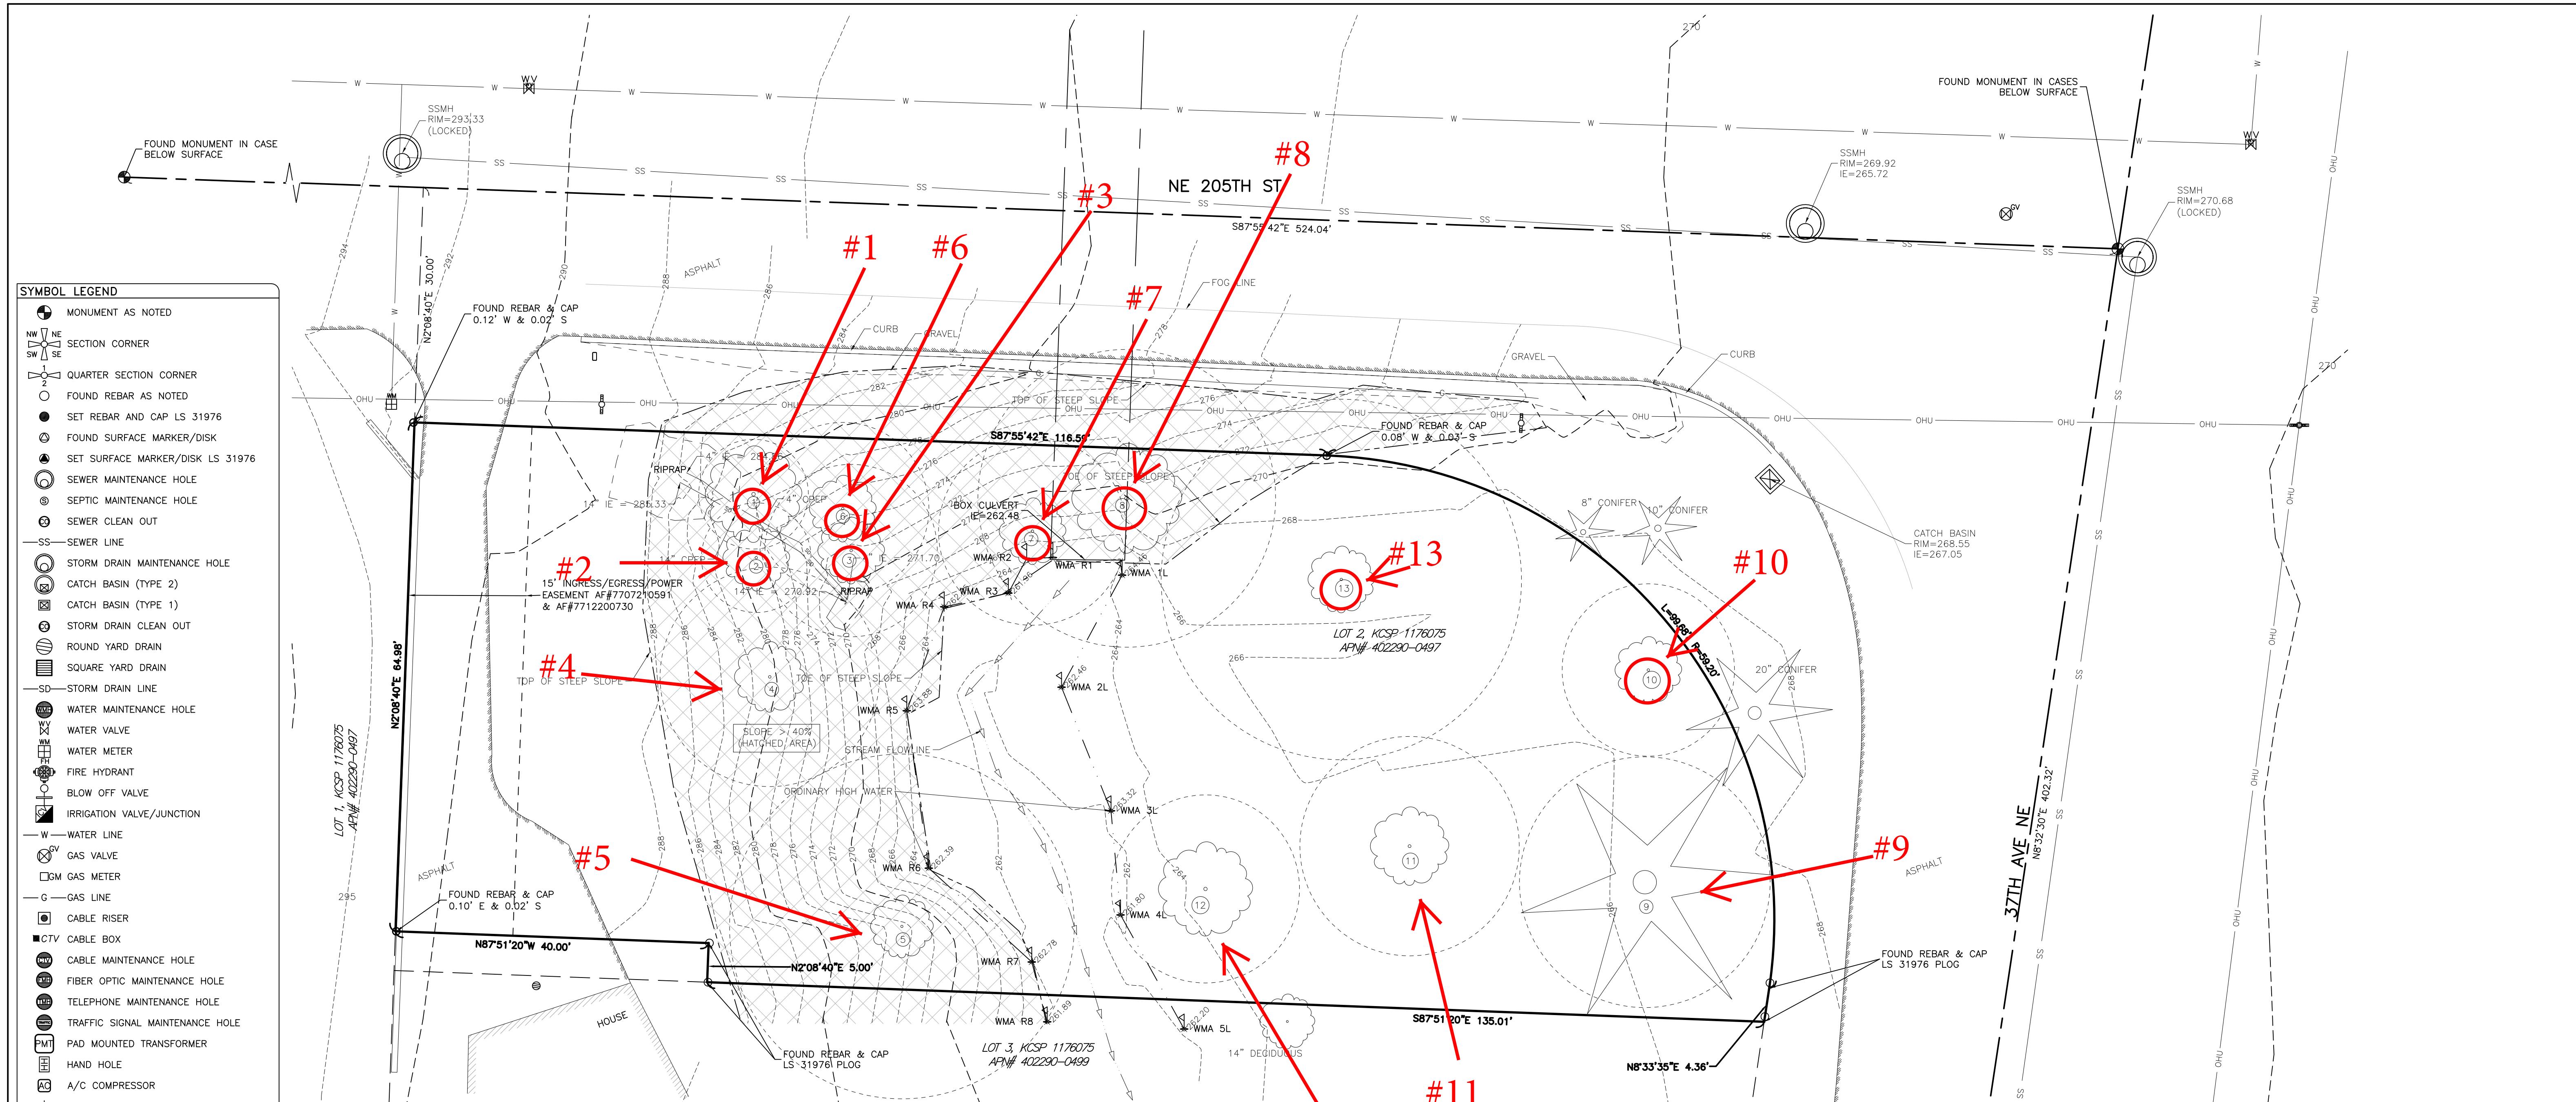
Appendix B: Tree Inventory Map

Trees were not tagged by The Watershed Company, but instead identified #1 - #13 on an annotated PDF (See Appendices). Canopy radius is the average branch length from the trunk as measured with a tape measure; tree height is a visual estimate. A basic Level 1 visual assessment was used to evaluate the health and condition of trees in the study area in accordance with the International Society of Arboriculture (ISA) standards.

Site visit was made by The Watershed Company
arborist on November 17, 2020
