November 23, 2020

Re: Garey Residence Arborist Report

The Watershed Company Reference Number: 190405

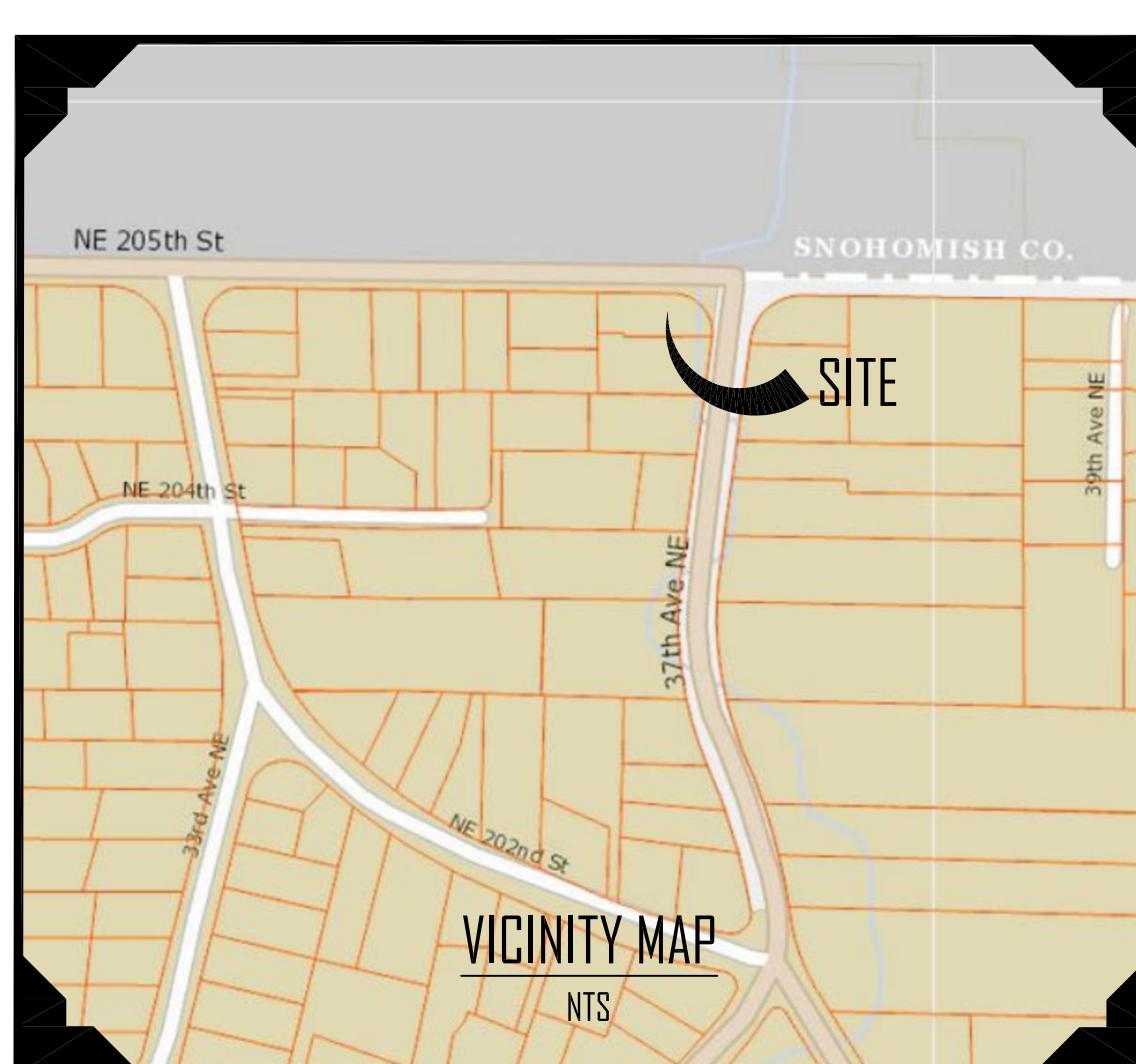
Site visit was made by The Watershed Company
arborist on November 17, 2020

TAG #	TREE NAME	DN / DEC	COMB. DBH (in)	HEIGHT (FT)	RADIUS (FT)	CONDITION	SIGNIFICANT (Y/N)	LANDMARK (Y/N)	NOTES	
									STEMS	DBH (in)
1	Alnus rubra (Red alder)	D 1	12.3	35	7	Fair	Y	N	Located on steep slope.	
2	Alnus rubra (Red alder)	D 1	8.6	40	7	Fair	Y	N	Located on steep slope.	
3	Alnus rubra (Red alder)	D 1	8.5	40	11	Fair	Y	N	Located on steep slope.	
4	Populus trichocarpa (Black cottonwood)	D 1	18.0	45	14	Dead	N	N		
5	Alnus rubra (Red alder)	D 1	19.0	45	22	Poor	Y	N	Has an uncorrected lean to the East over the stream. Growing in sandy soil which is showing some signs of uplift.	
6	Alnus rubra (Red alder)	D 1	8.6	25	11	Fair	Y	N		
7	Alnus rubra (Red alder)	D 1	8.5	25	12	Fair	Y	N		
8	Alnus rubra (Red alder)	D 1	14.0	25	19	Poor	Y	N	Branches intertwined with overhead utility lines.	
9	Thuja plicata (Western red cedar)	E 1	36.3	100	16	Good	Y	Y	Co-dominant stems at 7 feet.	
10	Prunus sp. (Cherry species)	D 1	9.0	60	11	Poor	Y	N	Ivy growing up stem.

11	Populus trichocarpa (Black cottonwood)	D 1	20.0	50	14	Severe	Y	N	Fallen over but still sprouting new growth. Root plate still intact and buried.	
12	Populus trichocarpa (Black cottonwood)	D 1	36.0	30	12	Dead	N	N		
13	Alnus rubra (Red alder)	D 1	8.5	55	23	Fair	Y	N	Ivy growing up stem.
