Consulting Arborist Services

Reference: Tree Inventory Report/Response to City Comments  
Tree Risk Assessment

Date: October 11, 2023

Site Address: 3803 NE 155th St, Lake Forest Park

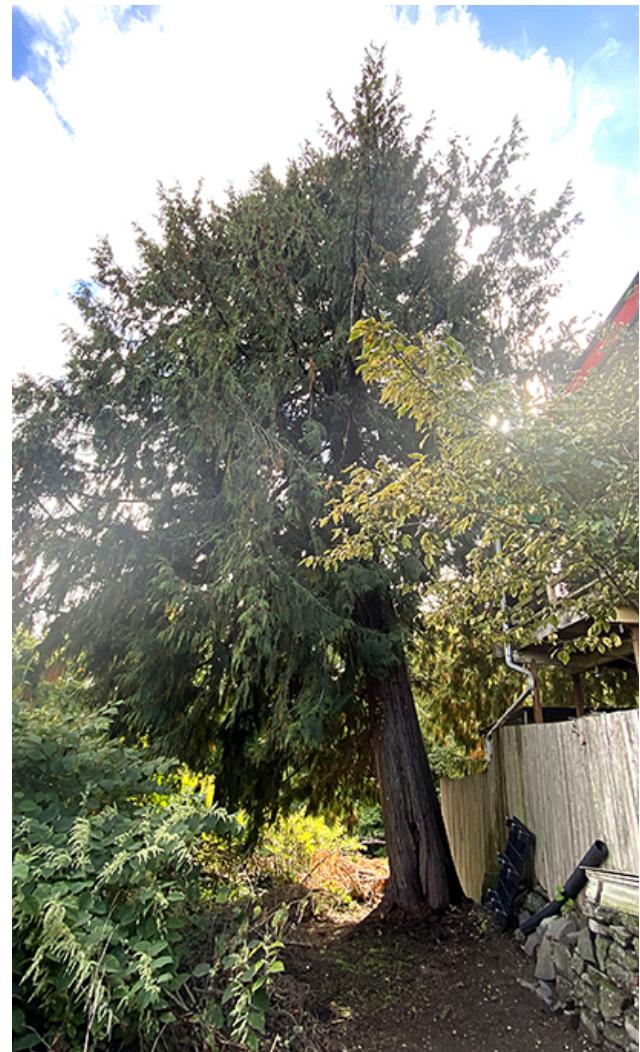
Right: Looking north, below the tree. Lean southeast. Neighboring foundation wall on left may restrict root growth. Structure/building limits rain to roots.
