STORM DRAINAGE REPORT

Proposed Single Family Residence

xxxxx 33rd AVE NE Lake Forest Park, WA 98155

Effective Engineering PLLC

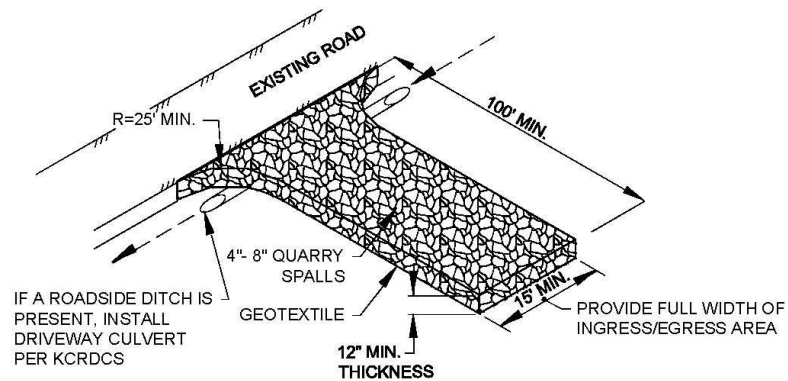
FIGURE C.3.1.A STABILIZED CONSTRUCTION ENTRANCE

- PER KING COUNTY ROAD DESIGN AND CONSTRUCTION STANDARDS (KCRDCS), DRIVEWAYS SHALL BE PAVED TO EDGE OF R-O-W PRIOR TO INSTALLATION OF THE CONSTRUCTION ENTRANCE TO AVOID DAMAGING OF THE ROADWAY.
- IT IS RECOMMENDED THAT THE ENTRANCE BE CROWNED SO THAT RUNOFF DRAINS OFF THE PAD.

1. See Figure C.3.1.A for details.
2. A separation geotextile shall be placed under the spalls to prevent fine sediment from pumping up into the rock pad. The geotextile shall meet the following standards:
