Comments on proposed development, Parcel #4022900497

File 2021-RUE-0001

RE: Arborist Report- Mark Garey property NE 205 Street and 37th Avenue NE, P#4022900497

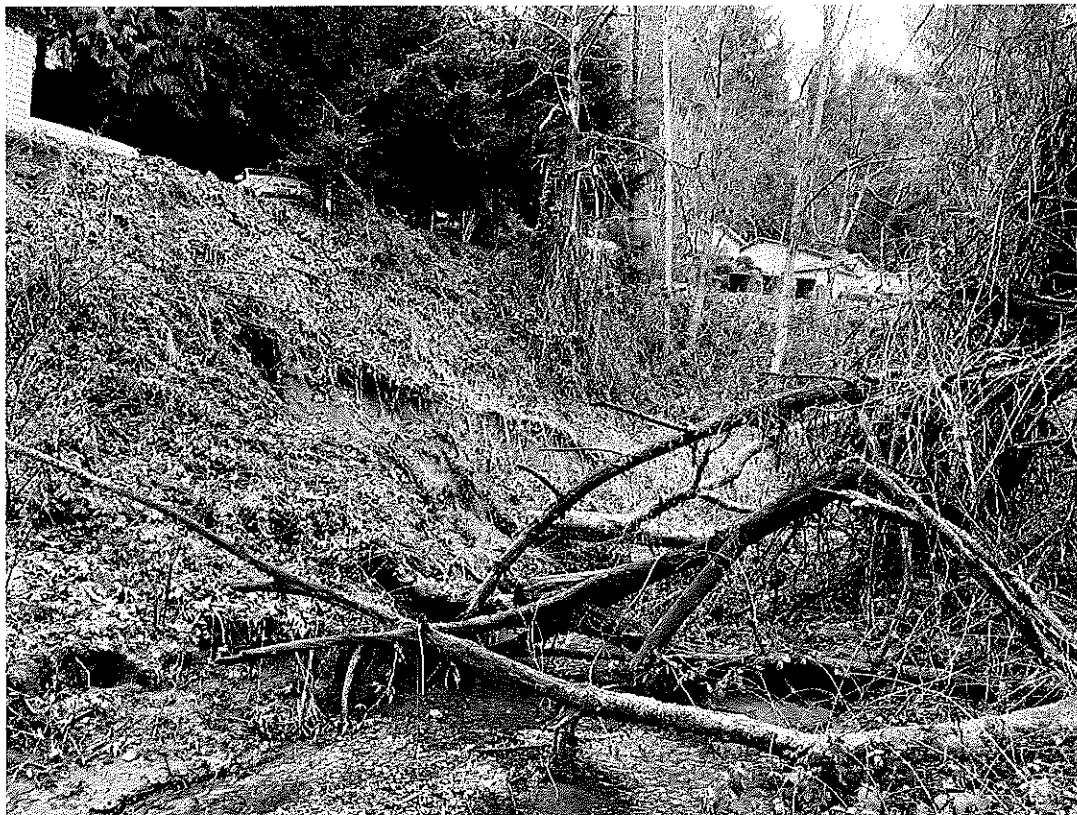
Photo 1. February 5, 2022. West side of property showing steep slope and recent slide

The west side of the parcel is a steep slope, and at the time of my visit 5 February 2022, there had been several active landslides down the slope (Photo 1). The east side of the parcel extends to 37 Ave NE. Much of this area appears to be part of the active floodplain of Lyon Creek. Fine soils suggest continuous sediment deposition throughout much of the area. I would strongly recommend that a wetlands specialist evaluates much of the area, and a geologist evaluates the suitability of this area for construction. The environmental functions provided by this floodplain: sediment retention and attenuation of storm events (high flows) are important to the health of Lyon Creek downstream. Loss of channel complexity and connectivity was cited by Kerwin (2001) as factor of decline, and this property represents one of the few areas where natural stream processes are still evident. The eastern portion of the parcel also provides a biological buffer for road run-off from 37th Ave NE.

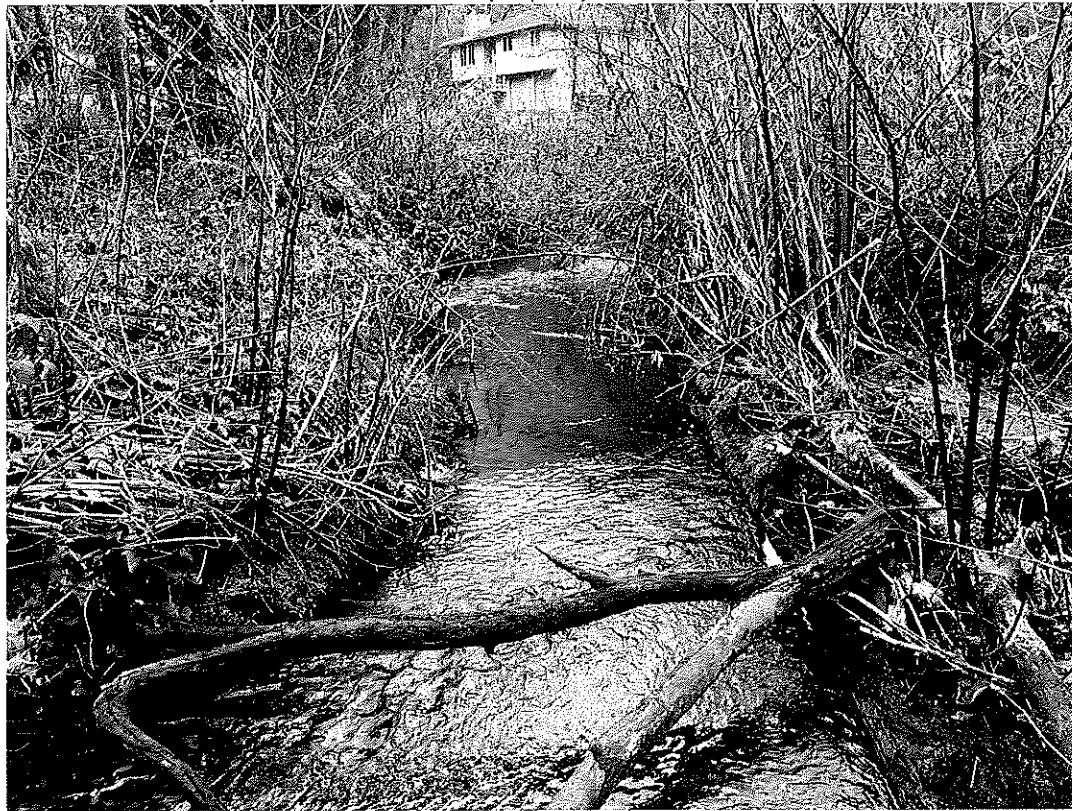
Photo 2. Looking downstream, Lyon Creek, note large log on right side and gravel in foreground

The stream reach in this area contained several patches of gravel, which appear to be suitable for spawning. It was also noted that there were several pieces of large wood in the stream (Photo 2). These are important in influencing stream processes, including pool formation and providing refuges for fish and other aquatic organisms.

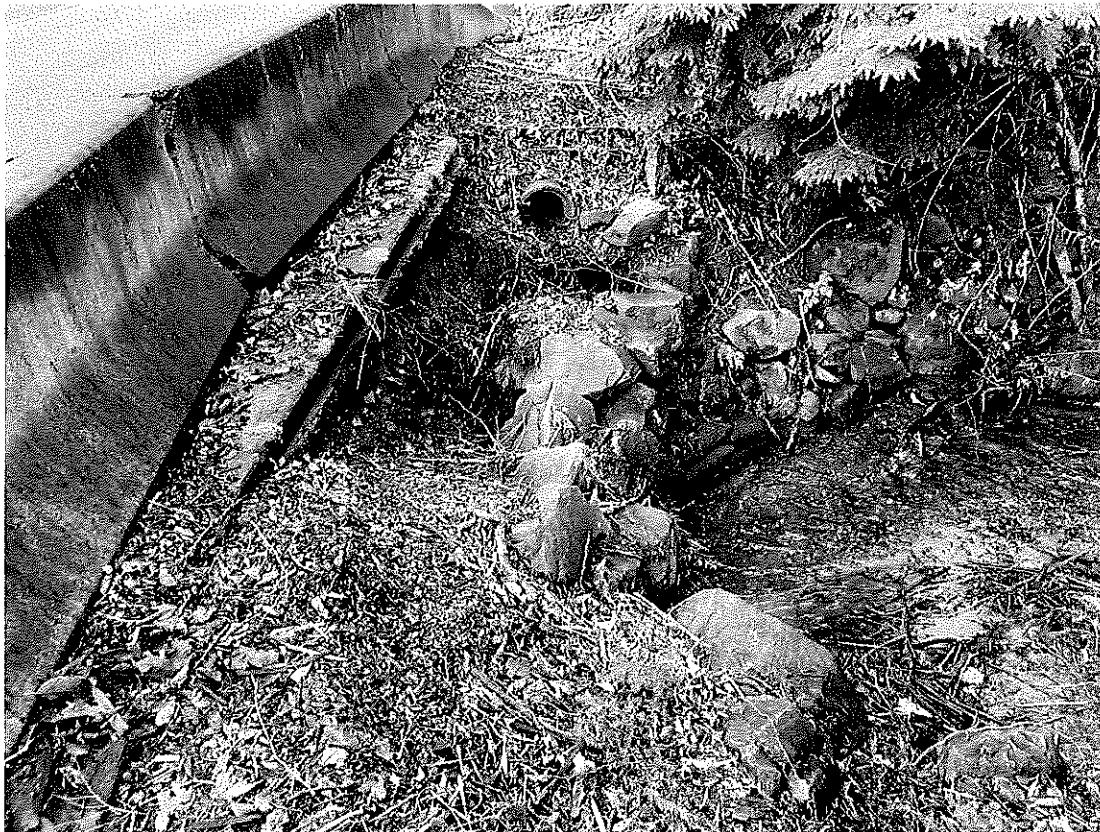
Photo 3. Culvert downstream of property showing storm damage.

Development of this parcel would remove any meaningful buffer at this location for Lyon Creek and would further degrade the environmental services that the parcels in this reach provide. I observed that the culvert downstream of the property was showing the effects of recent storms, a process that will only be hastened by development of this property (Photo 3).
